Final Report

**Southwest Supermarket Fire
35th Avenue and
McDowell Road**

**March 14, 2001
Incident #01-045301**

**Phoenix Fire Department
150 South 12 Street
Phoenix, Arizona 85034**

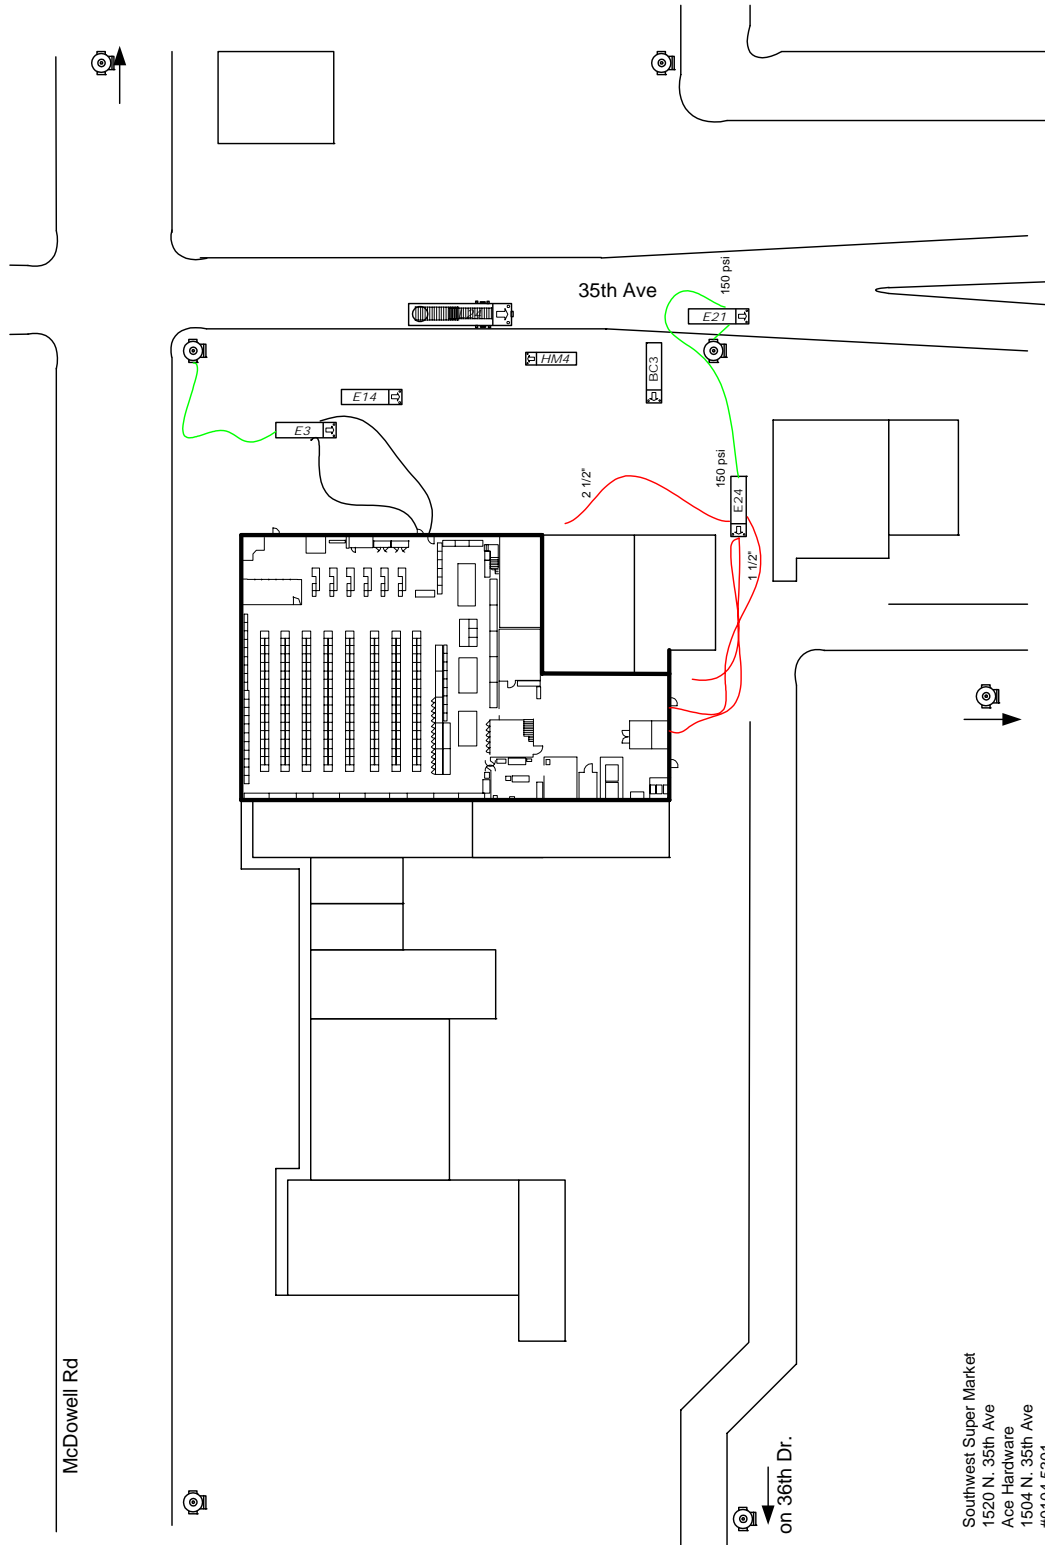
Initial Response

Engine 24 Dispatched	16:54:03
Engine 24 On-Scene	17:00:30
Battalion 3 On-Scene	17:00:30
Engine 14 Adds to the Call and Arrives On-Scene	17:01:49
Engine 3 Reports a Working Fire in the Storage Room	17:11:19
Firefighter Tarver Requests Help	17:26:38
Battalion 3 Assigns RIC Teams	17:27:16
Firefighter Tomazin with Firefighter Tarver	17:33:57
E25 Captain with Firefighters Tomazin and Tarver	17:36:46
Firefighter Tomazin Being Treated Outside	17:42:28
Firefighter Tomazin Loaded for Transport	17:46:47
Engine 6 Captain with Engine 25 Captain	17:47:29
Engine 25 Captain Out of the Building	17:49:26
Engine 6 Requests Help with Firefighter Tarver	17:52:56
Firefighter Tarver is Out of the Building	18:19:15
