STUDY: EFFECTIVENESS OF EXISTING GREEN INFRASTRUCTURE IN PHOENIX

8426900000-4400000001

City of Phoenix Contract No. 143989

December 28, 2018

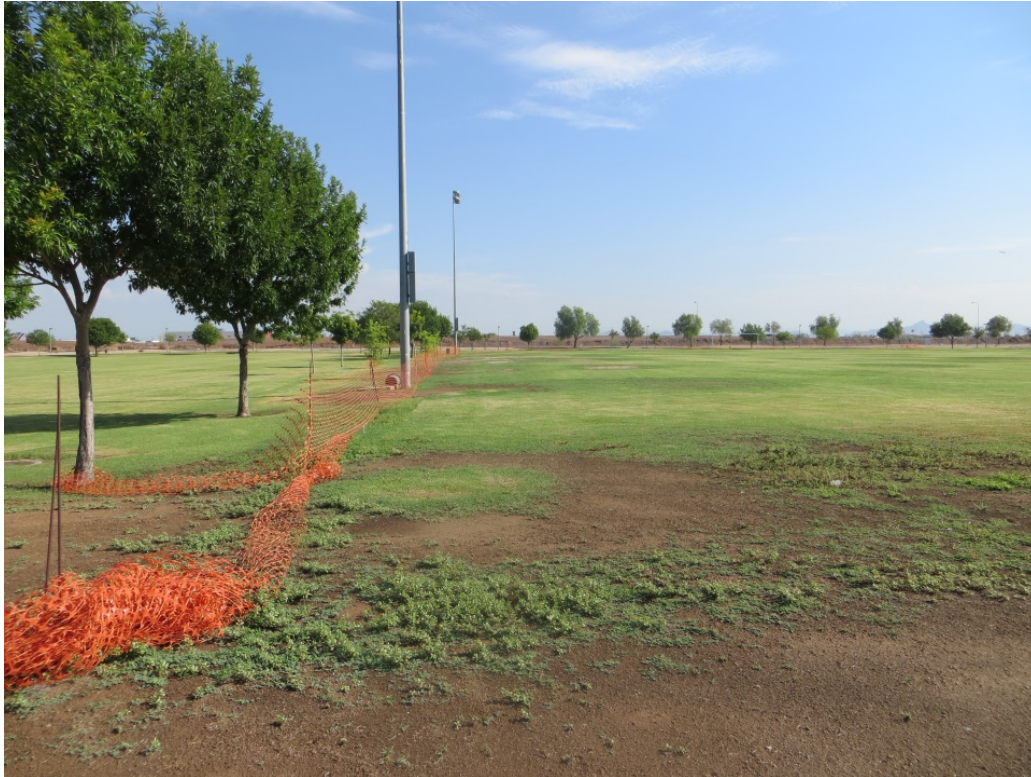
- Two weirs allow basins to meter to south channel (capacity of ~1.1 cfs)
- Basin stores over 693k-ft³ of stormwater runoff.
- Stormwater runoff is reduced by 95 from 48.2-cfs to 2.2-cfs (primarily by attenuation)
- Stormwater runoff is infiltrated at an average rate of 0.91 in/hr.
- Vegetation other than turf has 10%-15% coverage.
- Soil conditions match as-builts.
- Irrigation valve boxes need repair.
- Maintenance may not support the function of the bioretention.

- No understory or groundcover vegetation in/around swale that conveys water from street to the turf bioretention area. Benefits of slowing, filtering or cleaning stormwater may be reduced.
- Over 50% of trees in as-builts no longer exist.
- Bare spots in turf (assumption is from cars/heavy pedestrian-use) may decrease water infiltration rates.
- Flood irrigation and sprinkler systems may not promote efficient water use.

Manzanita Park Turf Bioretention

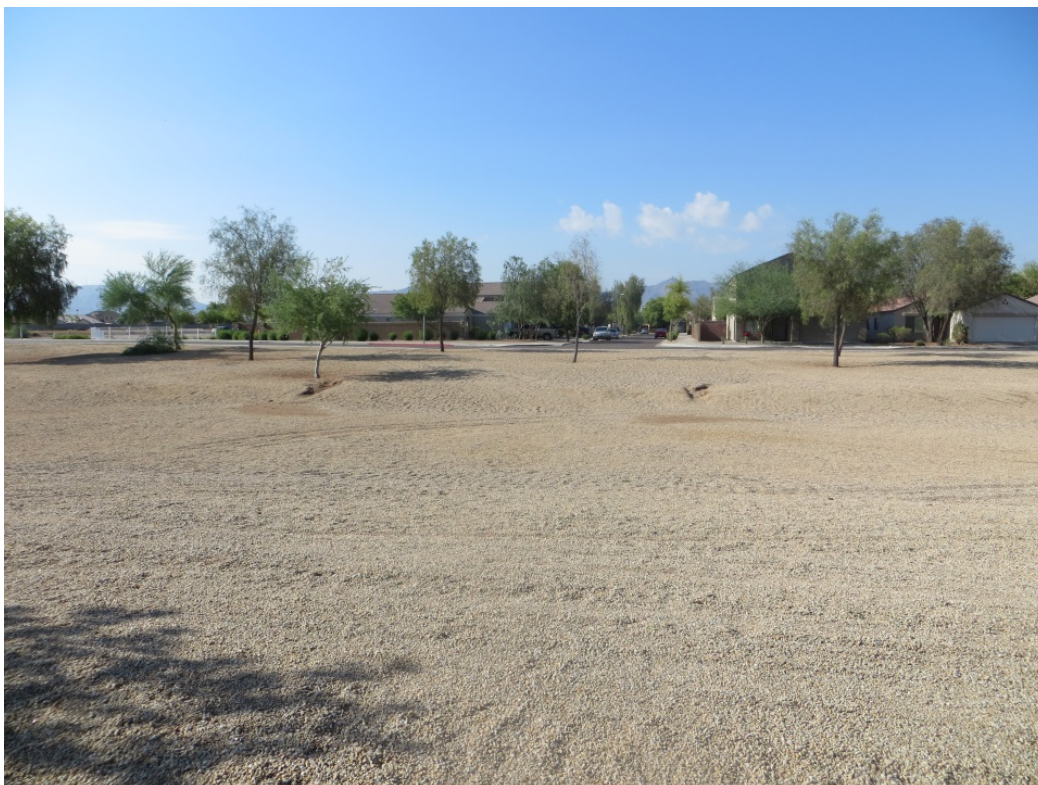
Manzanita Park Decomposed Granite Bioretention

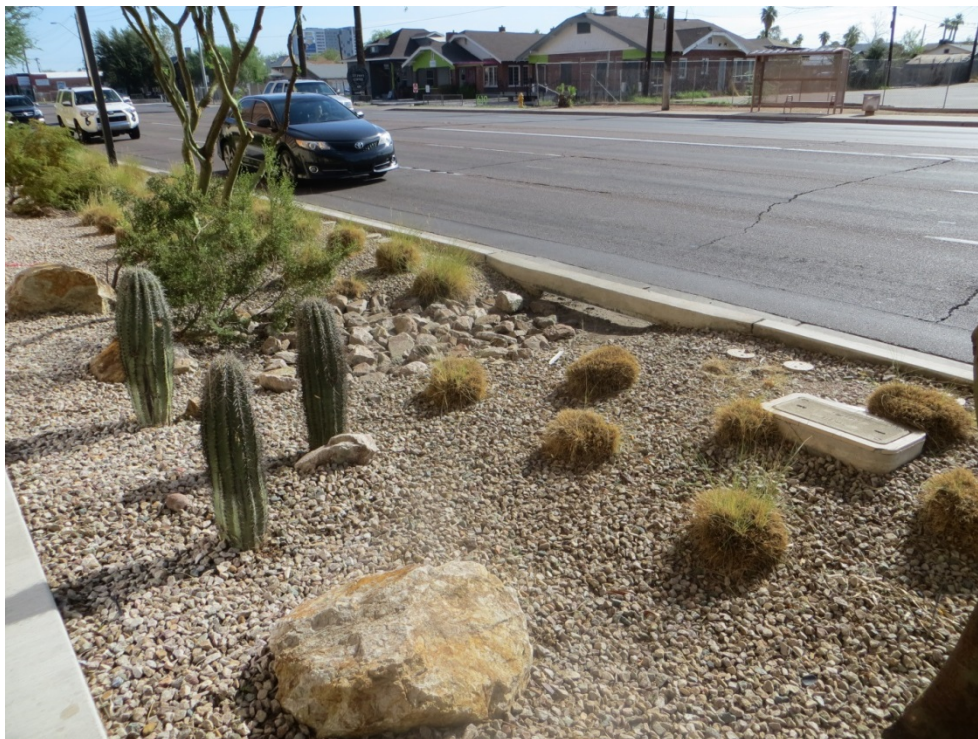
- Some holes in bioswale appear to have been left from a tree that was damaged or died.

Cancer Center Bioswale

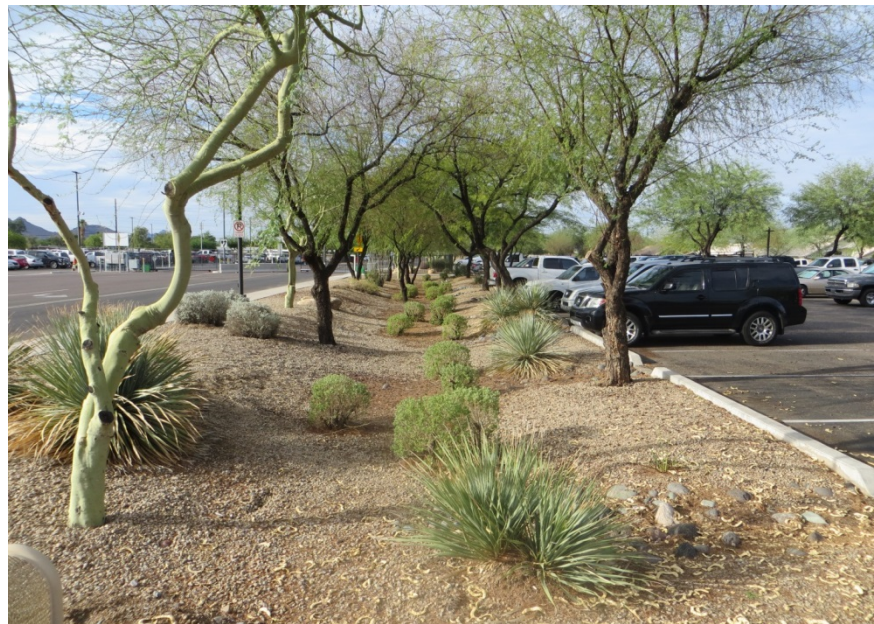
- Bioswale stores 5,063-ft³ of stormwater runoff.
- Bioswale infiltrates stormwater runoff at an average rate of 4 in/hr.
- Bioswale reduced stormwater runoff by 68% from 0.28-cfs to 0.09-cfs.
- Vegetation has 25% coverage. Soil conditions match as-builts.
- Irrigation valve boxes need repairs.
- Maintenance may not support the function of the bioswale due to extreme uplimbing of trees and shearing of shrubs.

Union Hills Service Bioswale

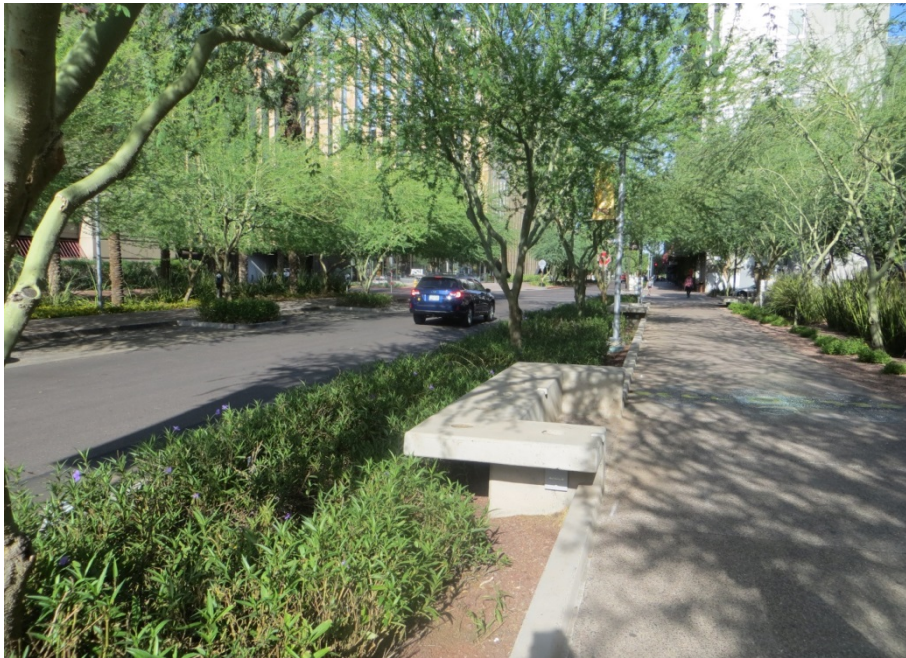
- Erosion at some inlets was amended with large rock not specified in as-built.
- Missing vegetation in basin between 2nd Ave. and 3rd Ave. allows pedestrians to cross through, thus aggravating bare areas and compacting soil, possibly leading to reduced infiltration rates.

Taylor Mall Bioswale

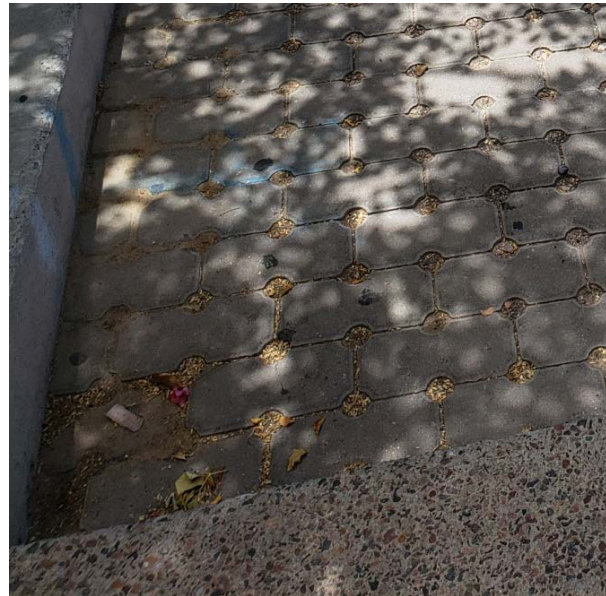
- Pavers around mid-section of parking bays are stained with oil drippings (see picture below) which may have seeped into paver joints
- Debris build-up is present in paver joints especially adjacent to trees (see picture on right)

Debris on Pavers

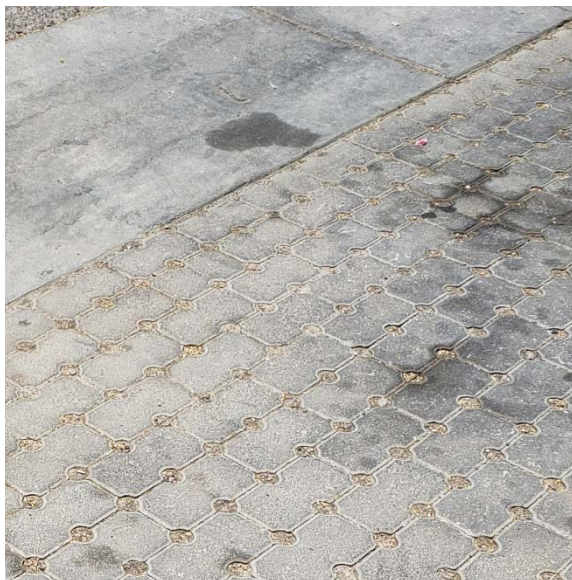
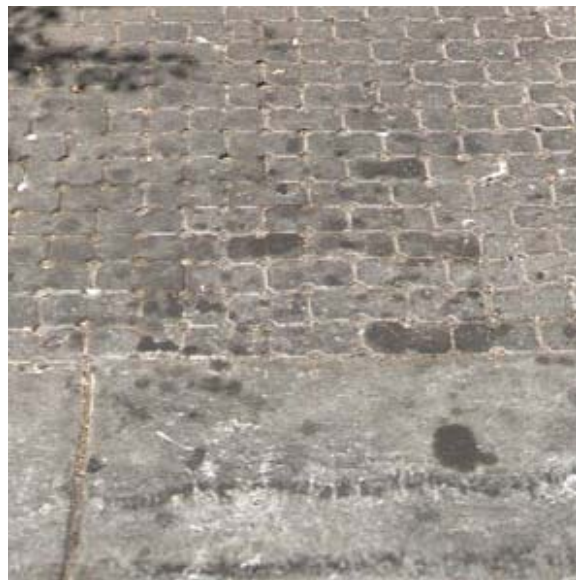
Oil on pavers

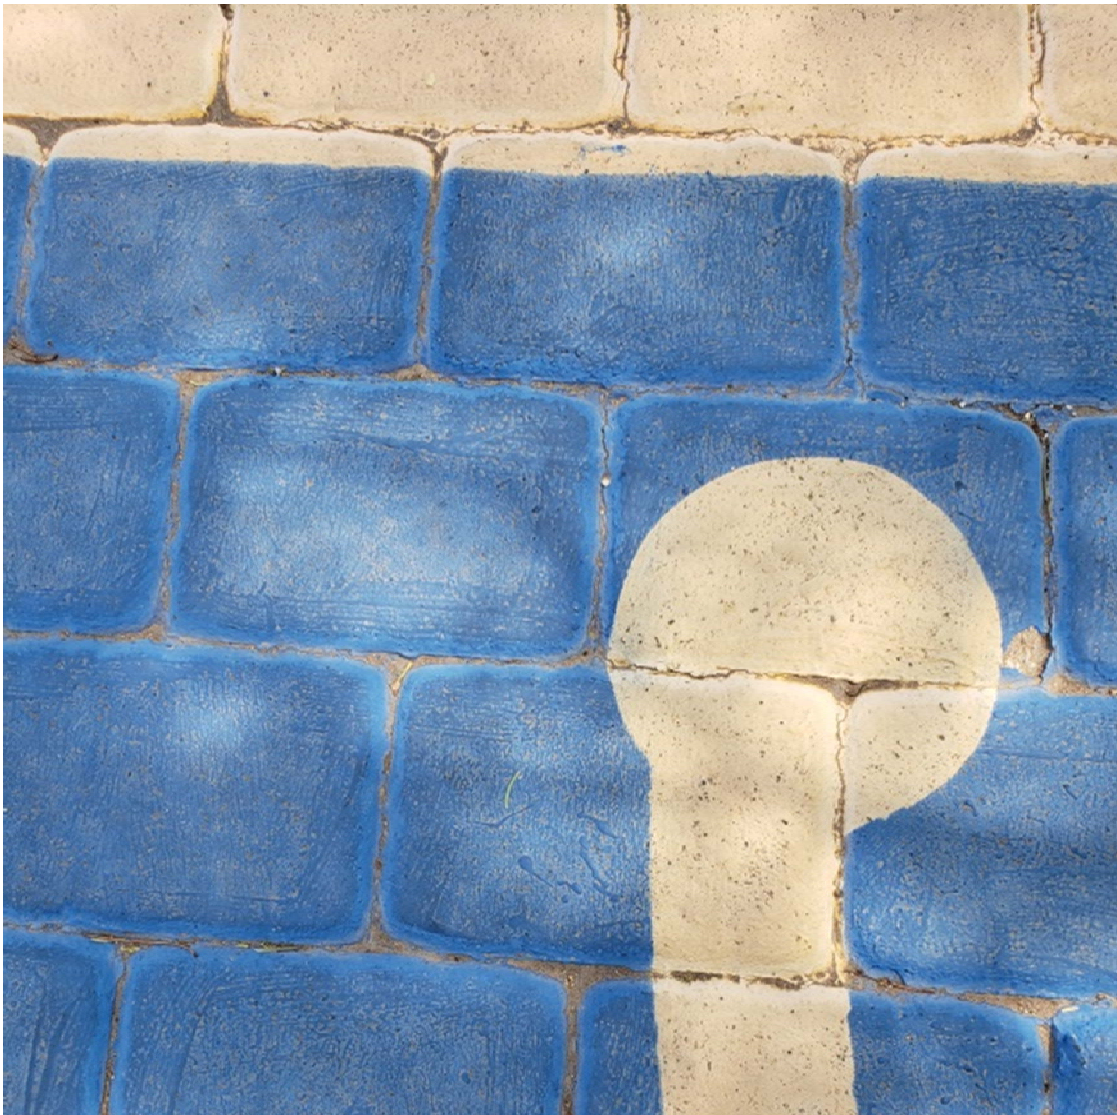
- Pavers do not allow water to infiltrate
- Handicap parking symbols were painted onto pavers and may be detrimental to infiltration function in these areas (see picture below)

Painted Permeable Pavers

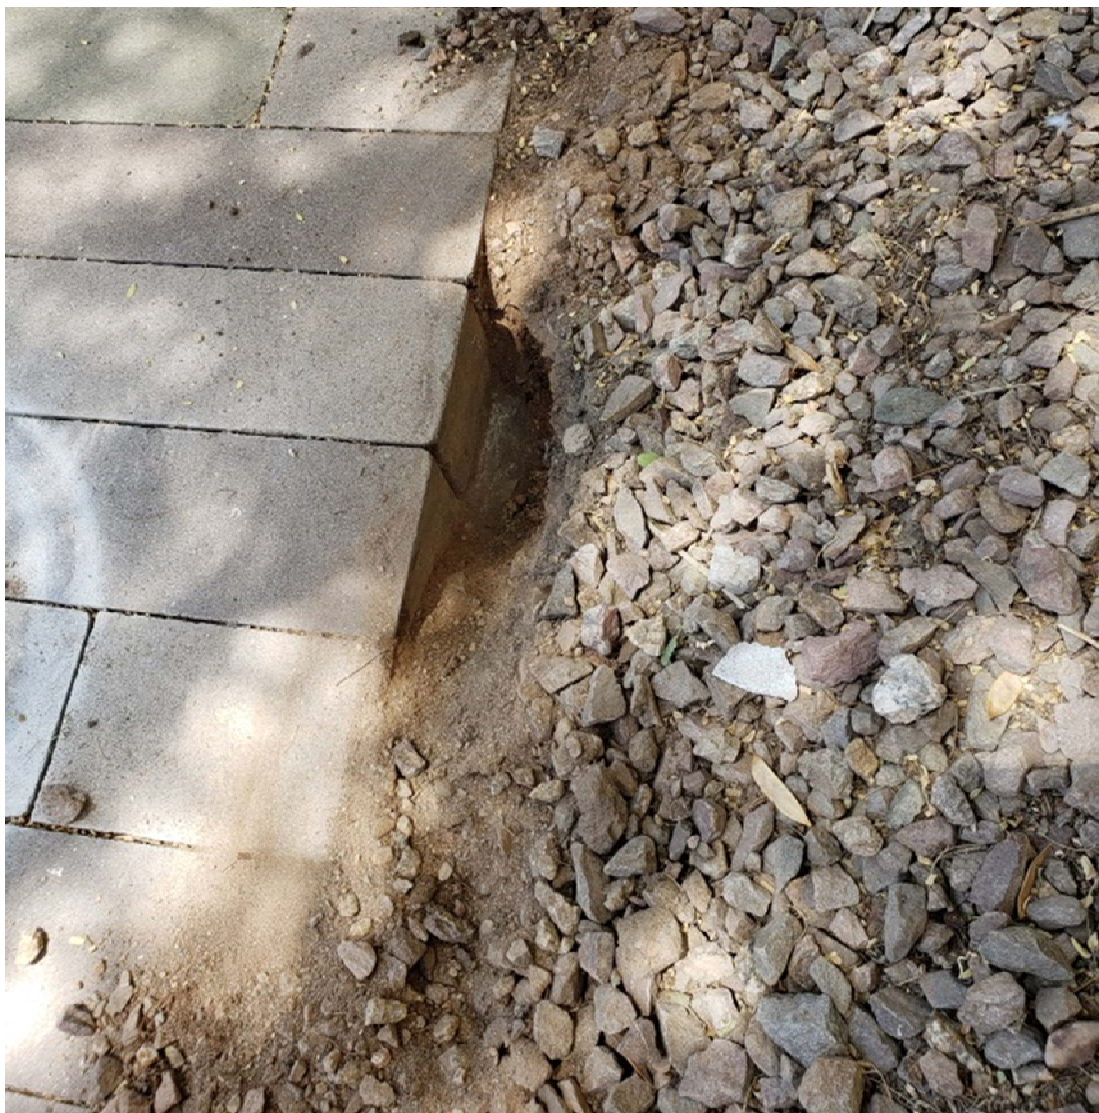
- One of the two site tested indicated no infiltration
- Permeable pavers could not be removed for subgrade testing due to narrow joints, or grouting of pavers near the perimeter (see picture below)

Grouted pavers around edge (header)

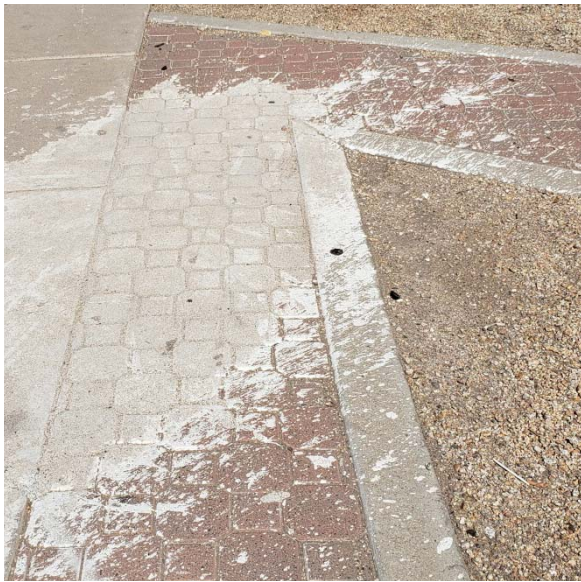
Paint spill over pavers

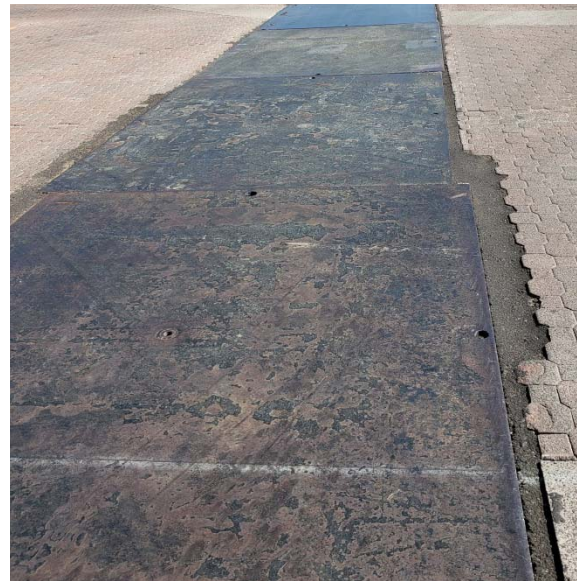
Trenching at intersection

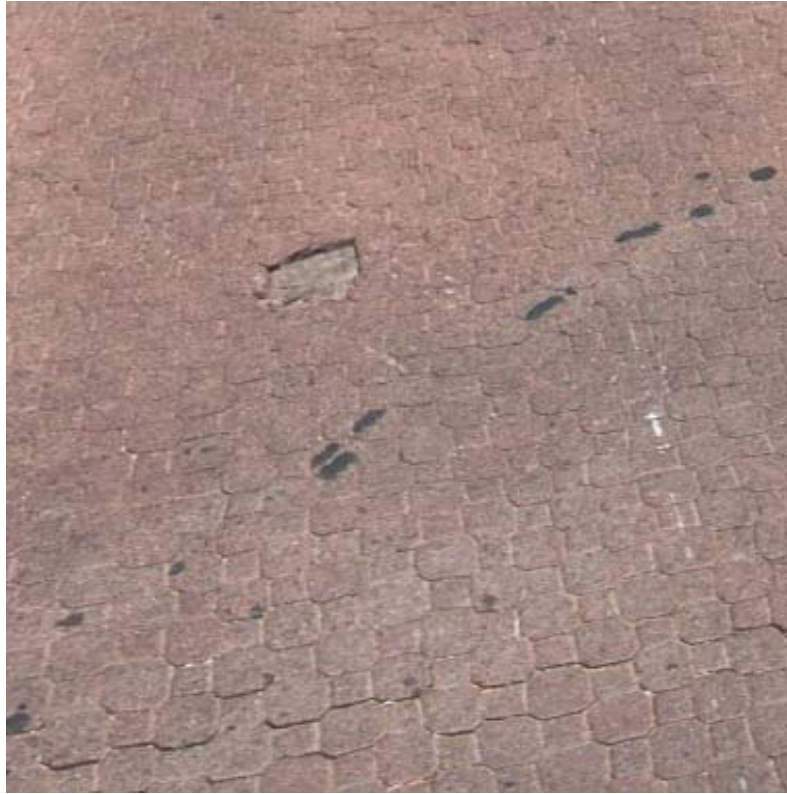
- No infiltration through paver joints and into the subgrade
- Pavers in the intersection are stained with oil that appears to have built-up over the years
- Excavations for underground utility repairs conducted subsequent to installation of pavers have not replaced the pavers leaving areas of the intersection as asphalt (see picture below).
- Pavers located at the northeast and southeast corners are clear of oil and grease but do contain adjacent landscape dust and smaller decomposed granite in the joints
- A white substance has been spilled over an area of pavers located at the southeast corner (see picture below)
- Permeable pavers appear to be grouted and therefore would not allow stormwater to be infiltrated and stored in the subgrade
- Missing pavers in the middle of the intersection (see picture on following page)

Intersection pavers missing and stained with oil and grease

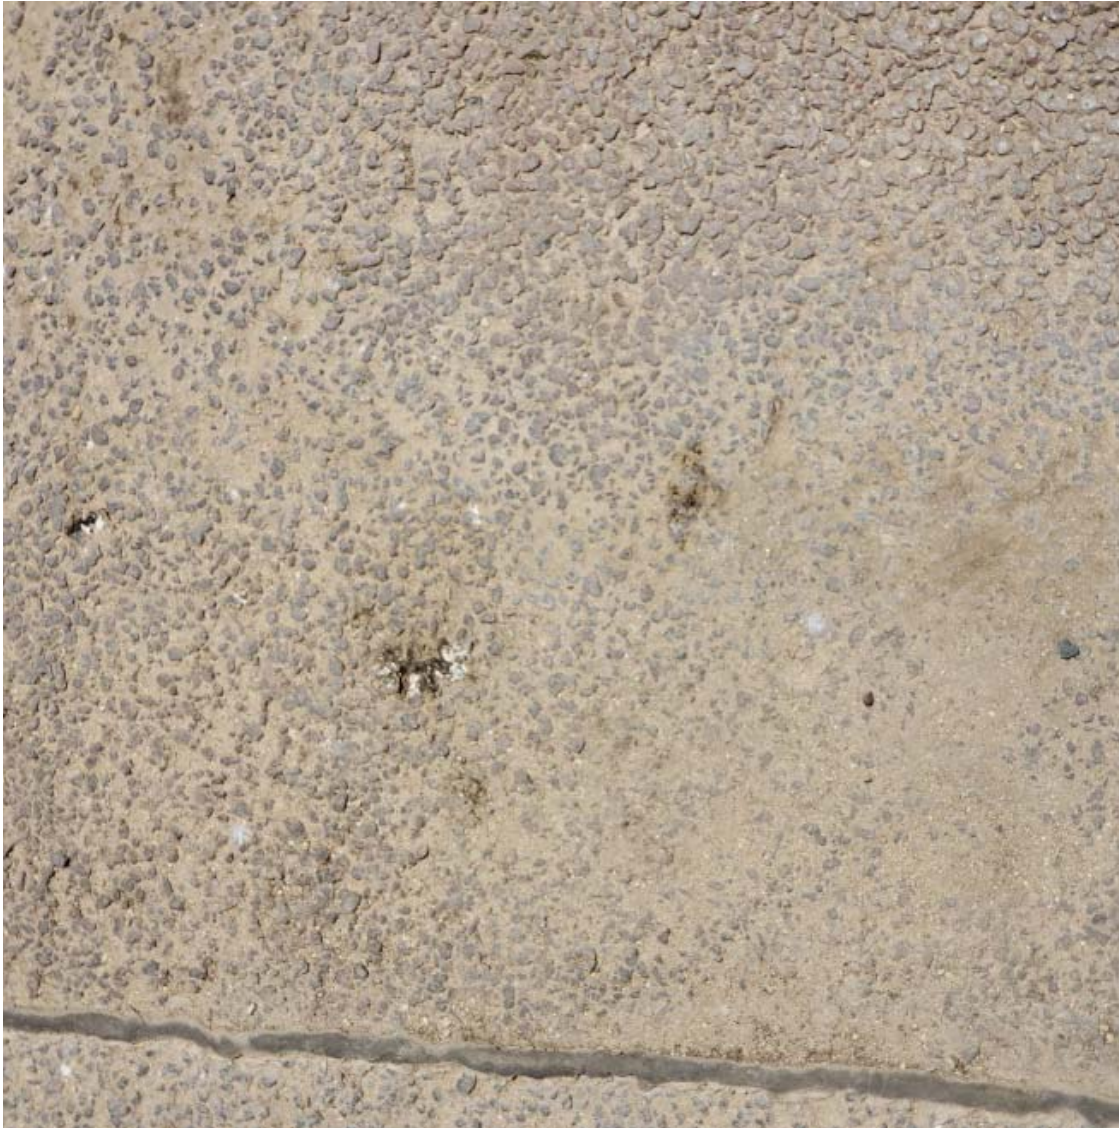
- The pervious concrete appeared to have sediment packed into the concrete and did not appear to be regularly maintained, which may prohibit infiltration and storage of stormwater (see picture on following page). As a result, the pervious concrete may perform like traditional concrete.

- Sediment build-up on pervious concrete throughout the park (see picture on following page)

Pervious concrete full of sediment

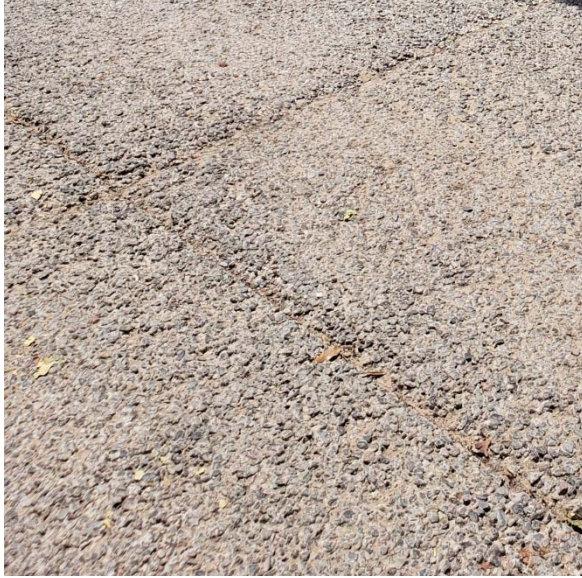
- Small areas of sediment and loose leaf debris (see pictures on following page)

Sediment filling surface voids

- The pervious concrete parking lot, with an average void content of 24% and an average depth of almost 7-inches, captures 5,991-ft³, nearly 75% of the equivalent 100-yr, 2-hr stormwater retention requirement of the pervious concrete parking lot.
- Stormwater runoff is reduced by 90% from 3.05-cfs to 0.32-cfs.
- Infiltration test results indicate water is being infiltrated at an average rate of 120.9 in/hr.
- Concrete surface is free of oils but does have pockets of debris and sediment (see picture on following page).
- Pervious concrete appears to handle traffic loads.
- Maintenance appears to be up kept regularly. It is recommended to vacuum the pockets of sediment that have infiltrated the voids.

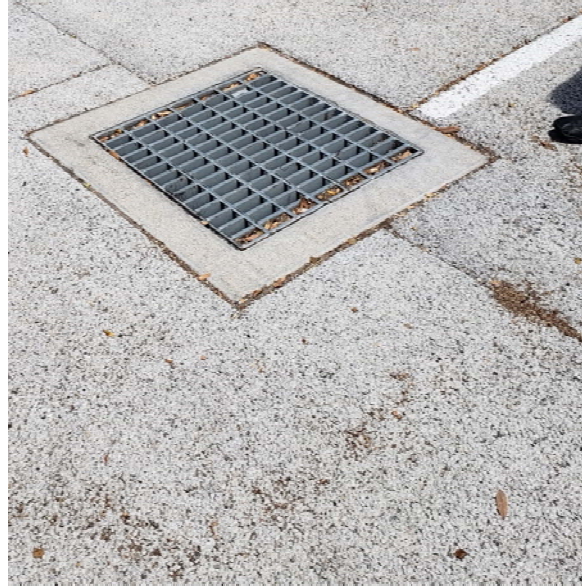
Loose leaf debris in pervious concrete

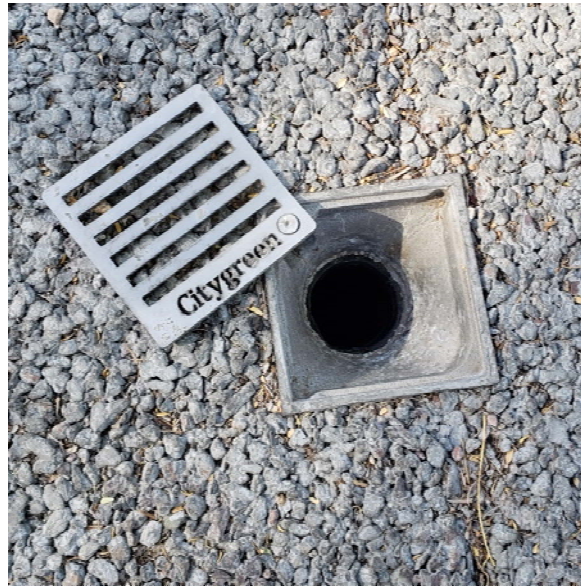
Unclogged drain inlet

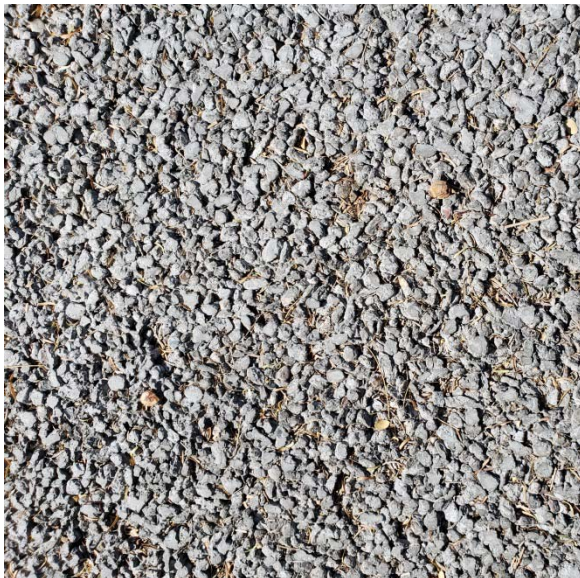
- Small drainage inlets in the pervious concrete mostly on the south side of Hatcher were clogged with debris.
- Voids were partially clogged with debris.
- HR-3 boring site did not infiltrate (see Geotechnical Report in Appendix D)

Pervious conc. partially clogged with debris

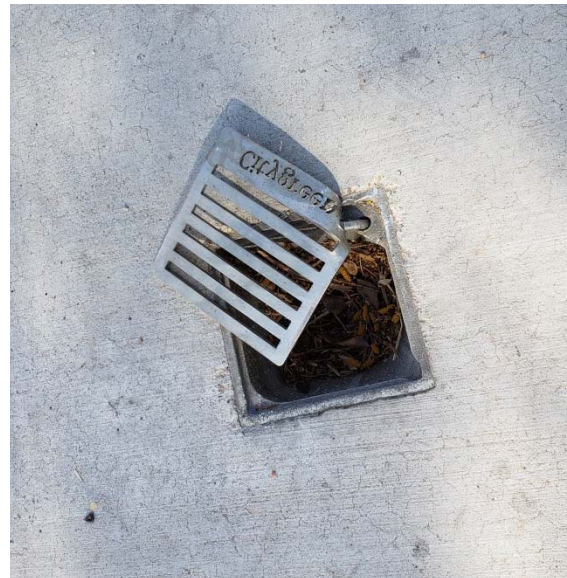
Clogged drain inlet

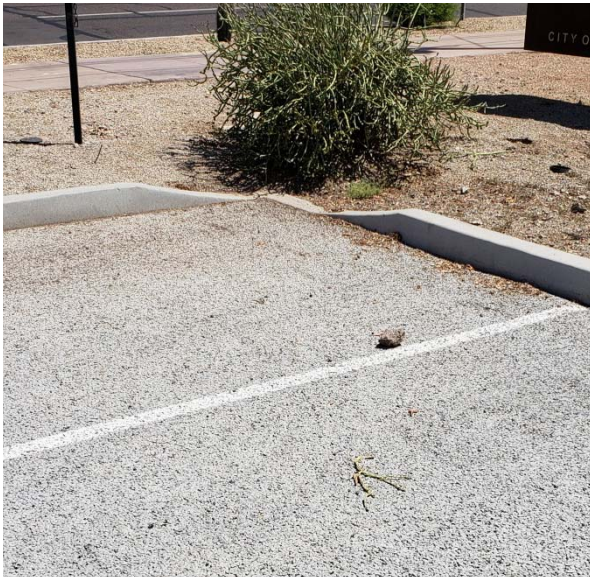
- Pervious concrete parking lot has an average void content of 15%, an average depth just over 6-inches and is able to store 635-ft³, equivalent to 47% of the 100-yr-2-hr stormwater storage requirement.
- Stormwater runoff is reduced by 90% from 0.49-cfs to 0.05-cfs.
- Infiltration test results indicate water is being infiltrated at an average rate of 71.4 in/hr.
- One test location (TC-1) has a very slow infiltration rate. Excess cementitious material was noticed in this location potentially sealing the voids of the pavement. This would indicate a mix design issue or an installation issue.
- Concrete surface is free of oils but does have pockets of debris and sediment (see picture on following page).

Debris buildup at sump locations

- Feature appears to be handling traffic loads.
- Maintenance appears to be up kept regularly. It is recommended to vacuum the pockets of sediment that have infiltrated the surface voids.
- Overall, the Tovrea Castle pervious concrete parking lot is performing well.

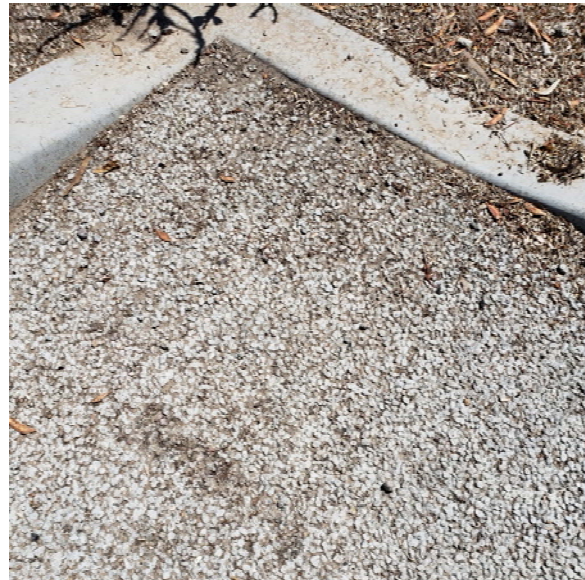
- Small areas of sediment and loose leaf debris (see pictures on following page)
- Handicap parking symbols painted onto pervious concrete which prohibit infiltration (see picture below)

Sediment buildup at sump locations

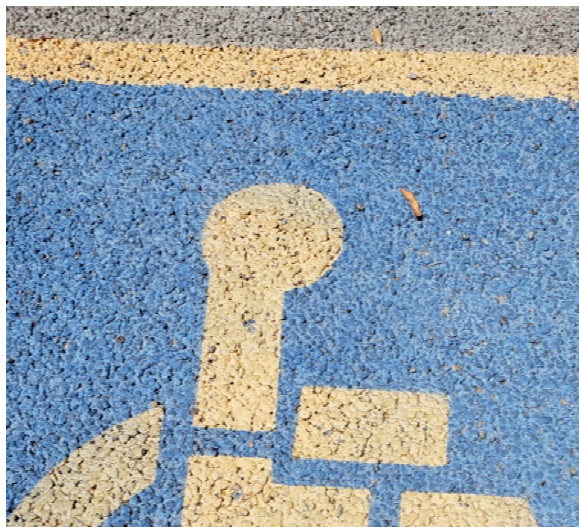
Painted handicap symbol

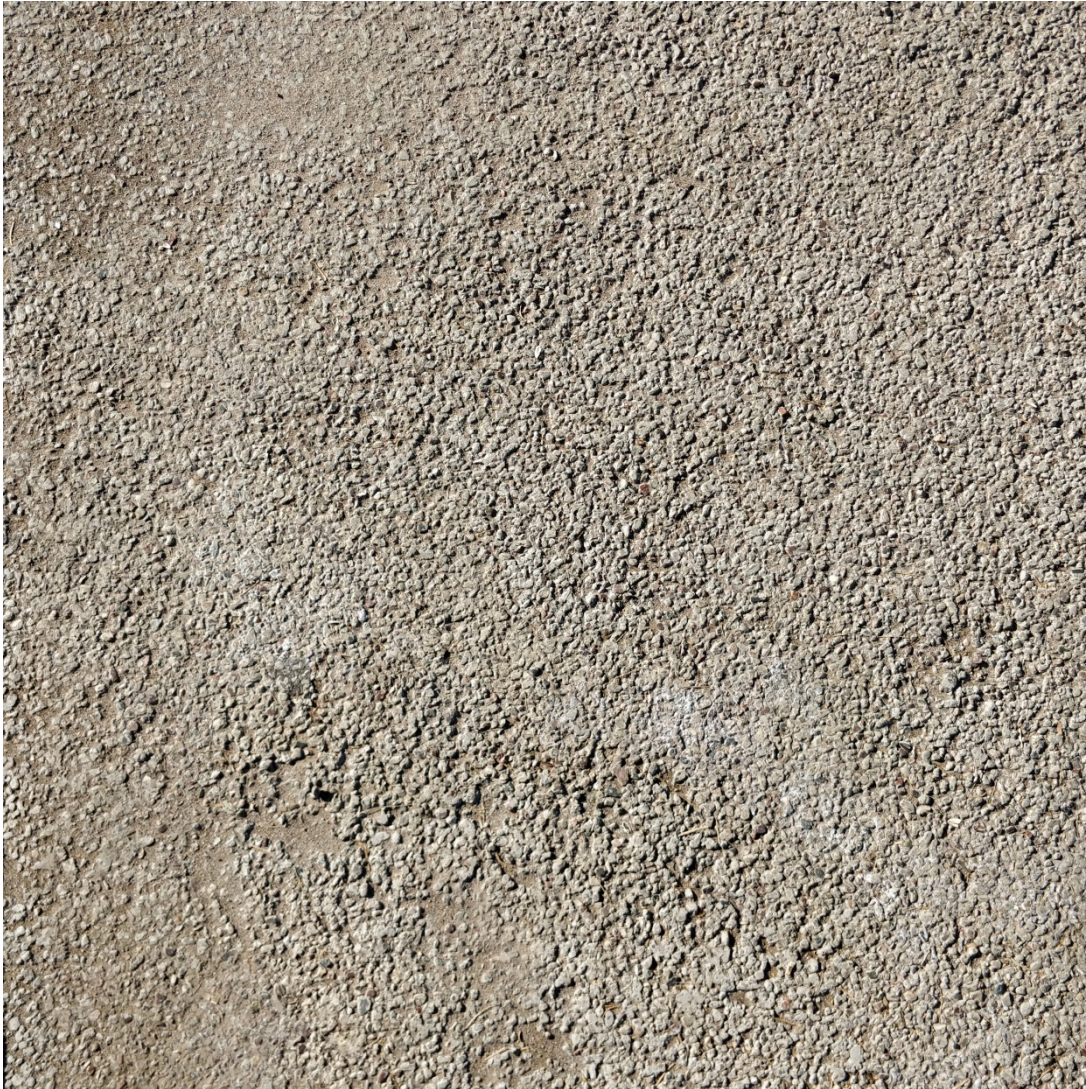
- The pervious concrete appeared to have sediment packed into the voids and did not appear to be regularly maintained, which may prohibit infiltration and storage of stormwater (see picture on following page). As a result, the pervious concrete may perform like traditional concrete. It is recommended to vacuum the pockets of sediment that have infiltrated the surface voids.
- Feature appears to be handling traffic loads.

- Sediment build-up on pervious concrete throughout the pavement (see picture on following page)

Sediment filling surface voids

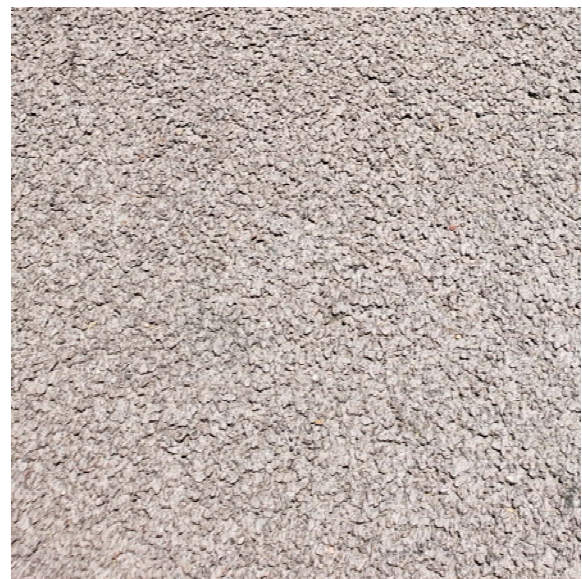
- According to the Geotechnical Data Report provided by Ninyo & Moore and observations during testing, it is suspected that the mix design may have contained too much water, which, after hardening, would have sealed it and prohibit it from infiltrating and storing water (see picture). As a result, the pervious concrete performs like traditional concrete and

Pervious concrete at Central Station

would not be considered a GI feature. City maintenance officials state that an integral color was mixed into the concrete.

- The pervious concrete is not infiltrating.

- No sediment blockages were observed at this specific location.
- Further investigation is recommended to determine a precise cause for the lack of infiltration.
