Current Conditions Report

Mobility Area 3: Durango Curve

City of Phoenix

August 2018
WSP Project No. ST872100034-1

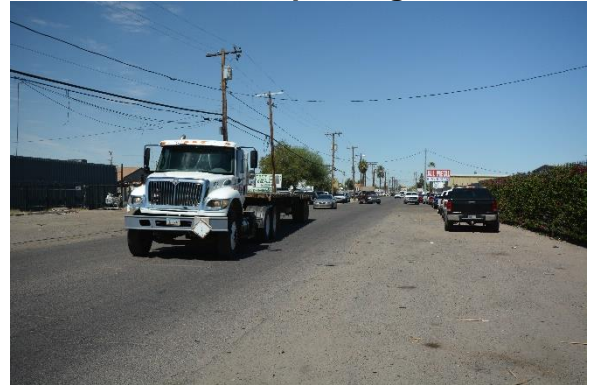
Figure 5-1: No sidewalks and informal on-street parking

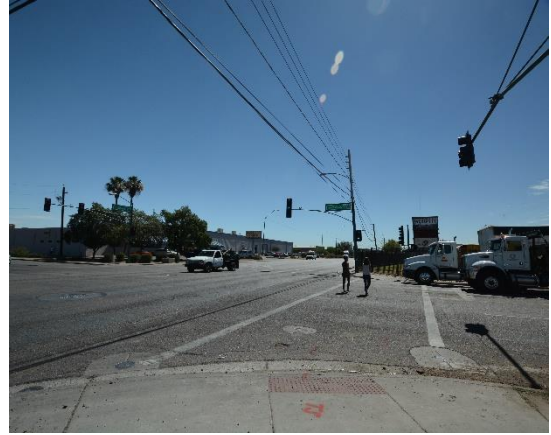
- The main safety concern for the Durango Curve area is Buckeye Road due to the occurrence of multiple pedestrian and bicycle crashes between 24th Avenue and 25th Avenue. The incidents appear to occur mid-block where there are no designated crossings, traffic calming devices, or signalized intersections.
- Highest concentrations of traffic volumes within the area also occur along Buckeye Road. Buckeye Road is a major east/west connector and is designated as a critical freight corridor through the area.
- Buckeye Road is designated as a major urban freight corridor.

Figure 5-2: Pedestrians crossing major arterial intersection

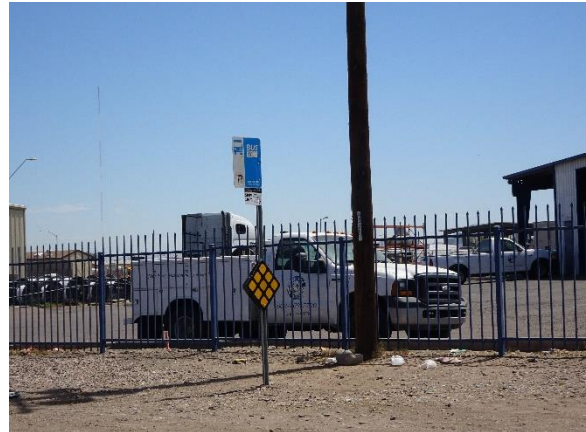
There are four fixed transit/bus routes that provide service in the Durango Curve study area (See **Figure 5-8**). **Table 5-4** shows the route, route type, route description, frequency, and key stops. Two bus routes, route 27 and 19, run NB/SB and two routes, route 13 and 28, run EB/WB. All routes have a frequency of 30 minutes, except Route 19, which operates at a frequency of 24-30 minutes. Key stops were identified based on the number of boardings and alightings. The key stops are located mainly along Buckeye Road and 27th Avenue along Route 27 and Route 13. Stops that are ADA non-compliant and ADA non-accessible were highlighted in **Figure 5-8**. In total, there are four (4) ADA non-compliant bus stops and four (4) ADA non-accessible bus stops within the study area, both do not meet current standards.

Figure 5-6: Bus stop along major arterial

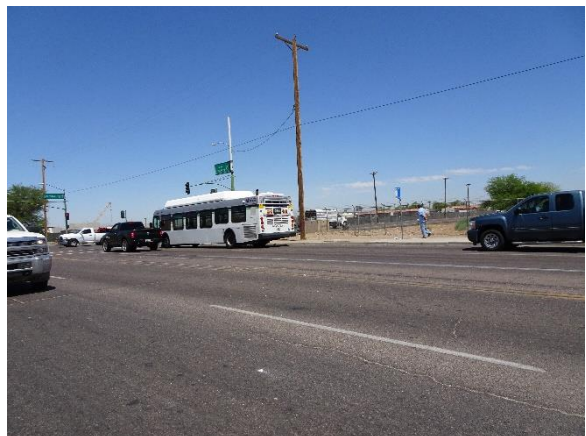
Figure 5-7: Bus stopping along major arterial

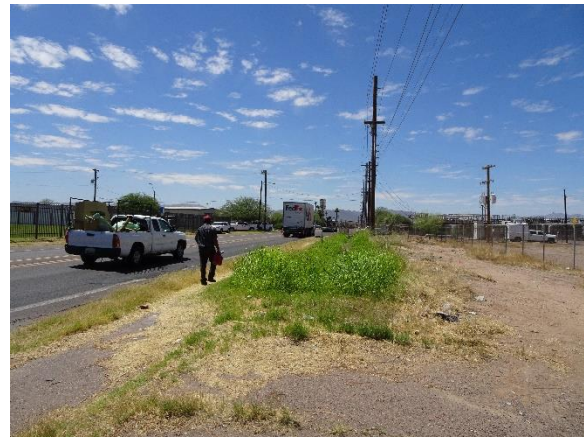
Furthermore, there are many gaps in the sidewalk infrastructure causing pedestrians to cross at mid-block or unmarked crossings. In addition to gaps, many sidewalks within the study area do not have a buffer from vehicle traffic, thus making the utilization of these sidewalks less attractive due to the proximity of moving vehicles. Areas without any sidewalk include:

- Both sides of 25th Avenue
- Both sides of 27th Avenue between Durango Street and Yuma Street
- Both sides of 29th Avenue

Figure 5-9: Missing sidewalk

- Sections on both sides of Buckeye Road between 23rd Avenue and 29th Avenue, and
- Approximately one-half of all neighborhood streets have no sidewalk

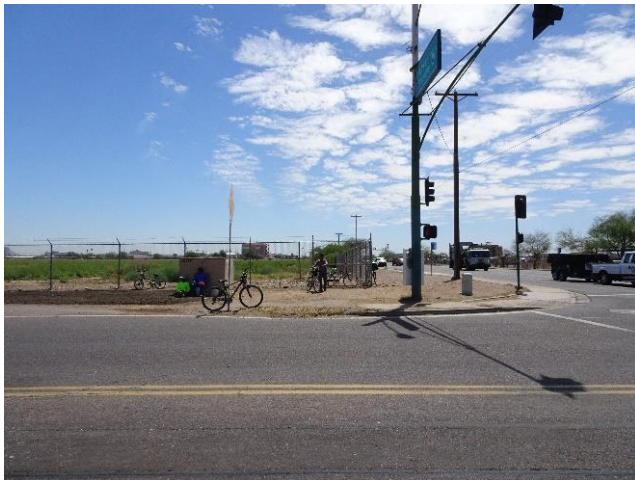
Figure 5-11: Bicyclists using the sidewalk

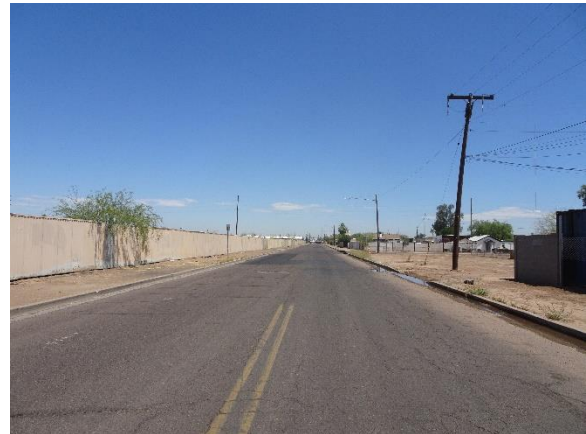
- Lighting infrastructure is highly concentrated along major roads and sparingly located within neighborhoods.
- There is no street lighting in the southern portion of the study area where the State, County, and City facilities are concentrated.
- Smallest number of street lights is along Lower Buckeye Road with a total of eight (8) light poles.

Figure 5-13: Street lights on one side of the road

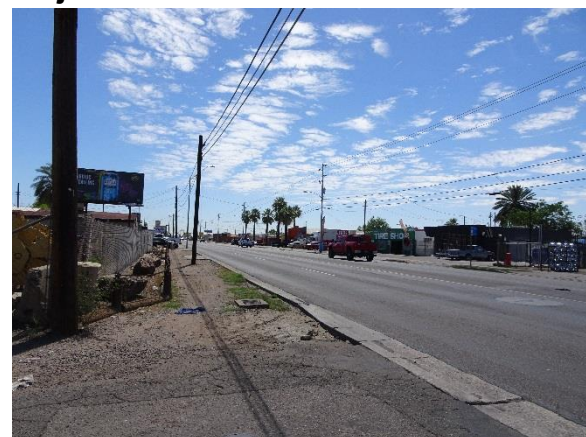
Figure 5-14: Street lighting along major arterial

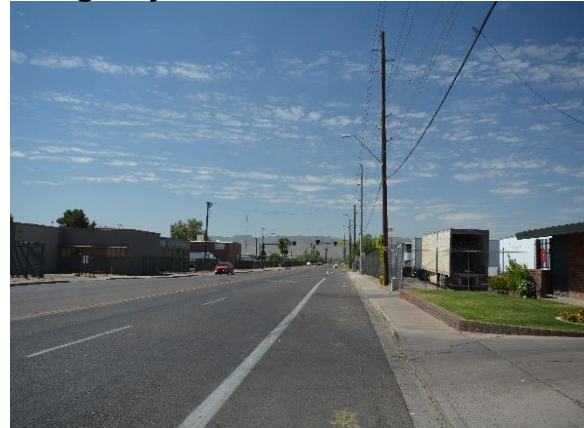
Figure 5-16: Lack of landscaping along major arterial

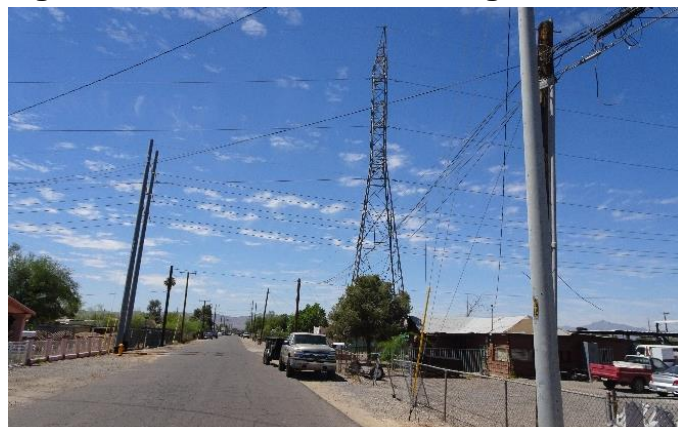
- Overall, the Durango Curve study area does not have significant tree coverage or shade within the public ROW.
- The concentration of trees along Lower Buckeye Road is near the same locations as the eight light poles identified in the previous section.
- Most shade trees do not provide adequate shade for pedestrian and bicycle facilities due to spacing.

Figure 5-17: Lack of shade along local street

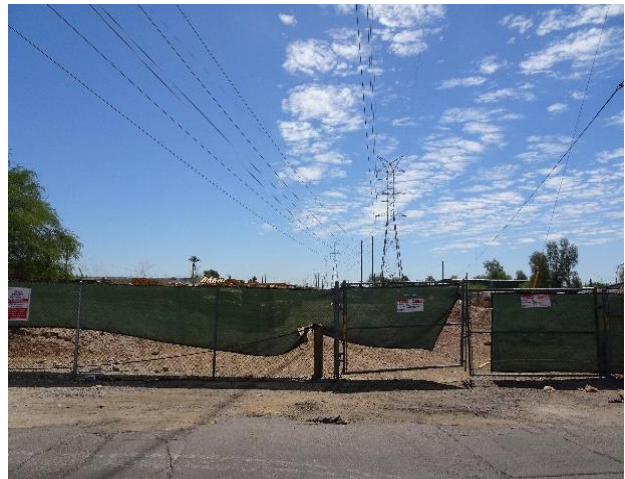
Transmission lines run east/west between Sherman Street and Hadley Street through the Durango Curve study area (See **Figure 6-5**). The current transmission lines create a barrier on 24th Avenue between development on the north and south sides of the fenced transmission lines (See **Figure 6-3**). Mobility improvements will build upon additional utility information as it becomes relevant in the development of project recommendations.

Figure 6-3: Utility barrier
