South Mountain Park

Design Guidelines Manual

October 2015

In January 2015, the City of Phoenix Parks and Recreation Department initiated a study to analyze the existing conditions of major elements in South Mountain Park and offer recommendations to determine the costs necessary to improve the quality of the natural desert experience afforded to park visitors.

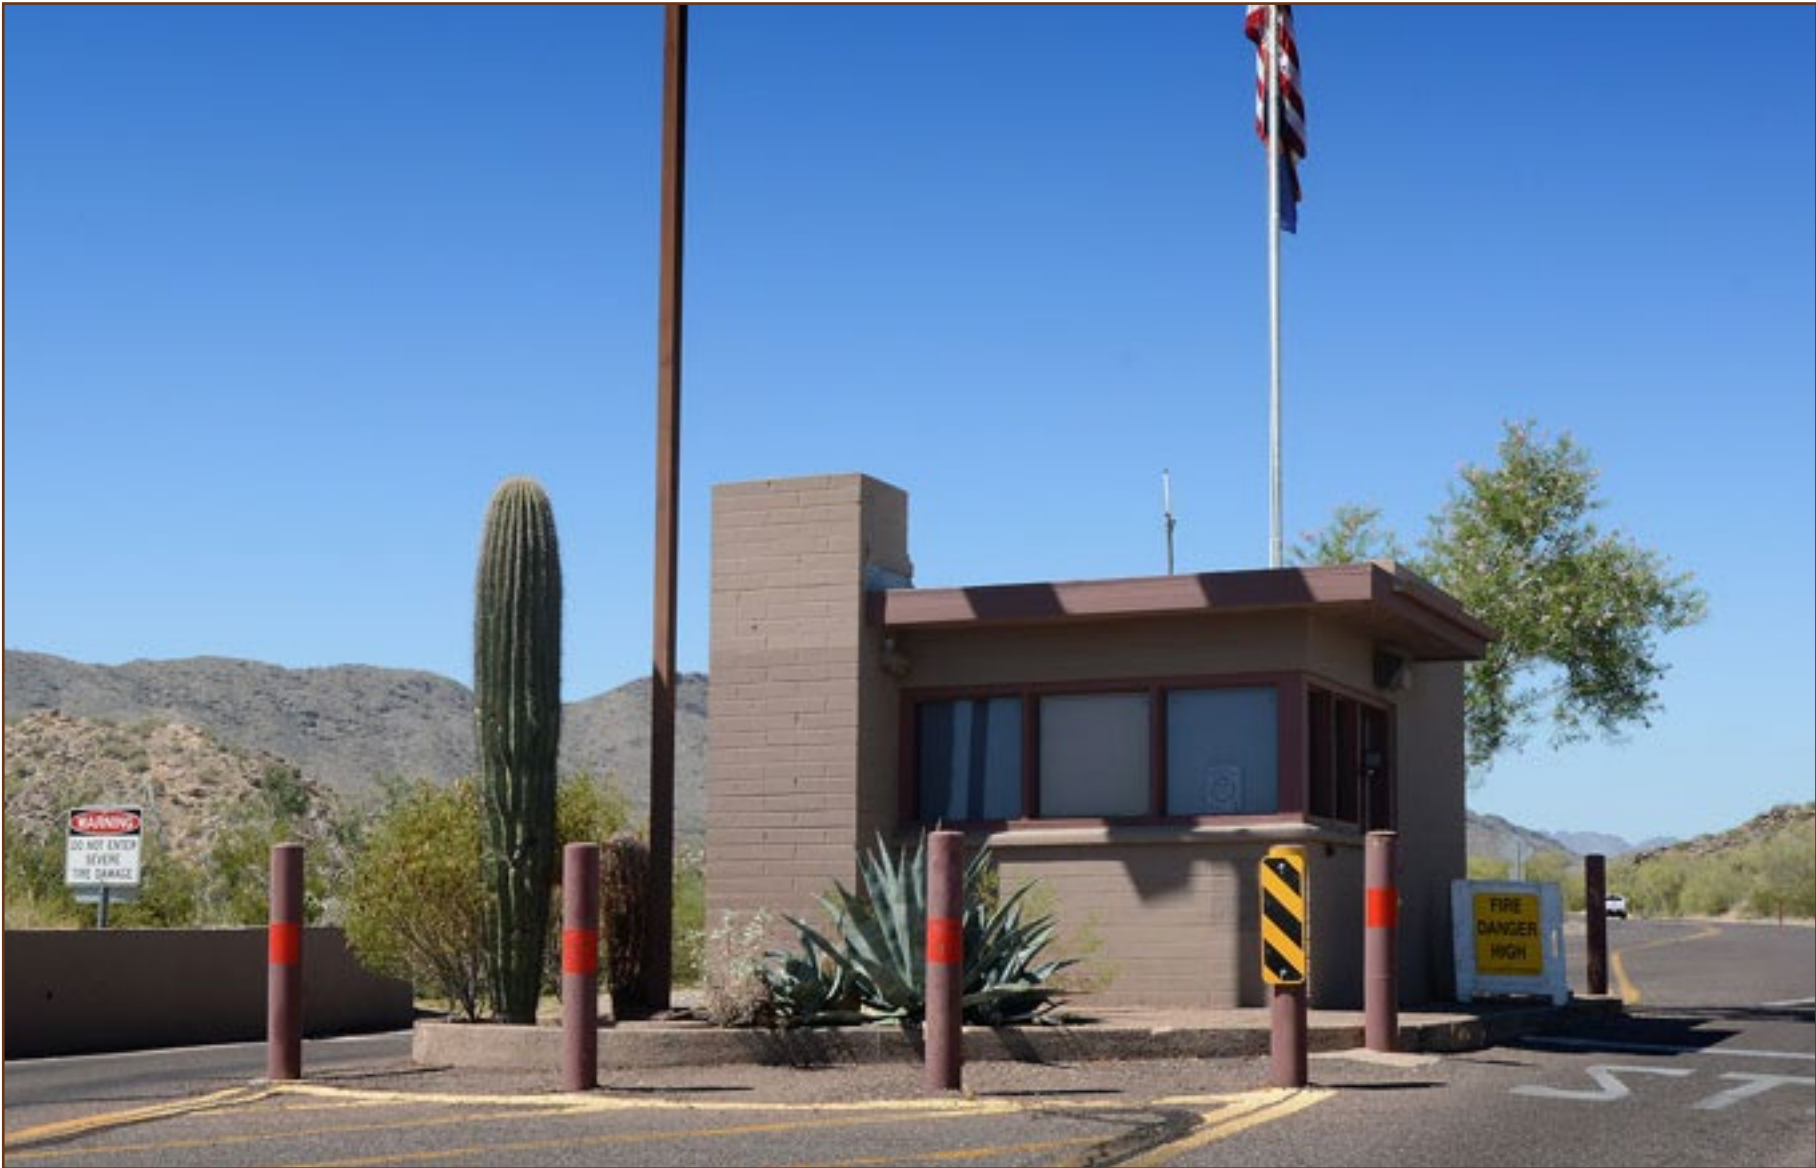
Existing Conditions

The existing park entrance guard station located just west of Scorpion Gulch and is more than 20 years old and in need of renovation. Also the Guard Station is an unappealing first impression at the park’s entrance.

Recommendation: The first guard station should be retained and renovated to create a more appealing image compatible with the City's park style architectural guidelines. The conceptual rendering illustrates replacing the simple gable roof with a more dramatic roof form, applying steel siding over portions of the masonry walls, and replacing the doors and windows. The second guard station visually obstructs the view of the Historic Entrance Complex. It was inappropriately constructed with materials that closely resemble the historic structures giving the false impression of an original or historic structure. Since there is no foreseeable need for a guard station at this location we recommend it be removed in its entirety.

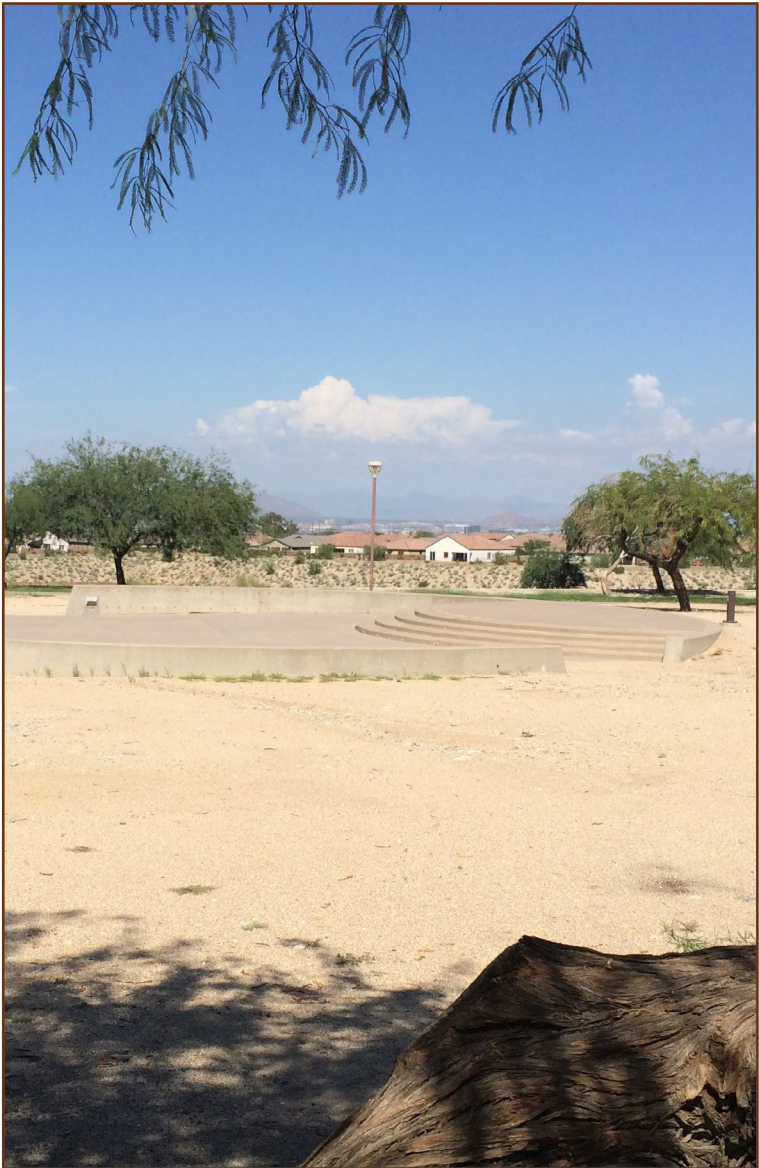
Existing Conditions

The Activity Complex located near the park entrance was constructed for traditional park use. However, due to neglect, lack of programming and few amenities, the complex is seldom used. There are two existing public restrooms and a commercial kitchen facility, built in the 1970's exist on the site. Large parking lots are located adjacent to the complex and available for large group events.

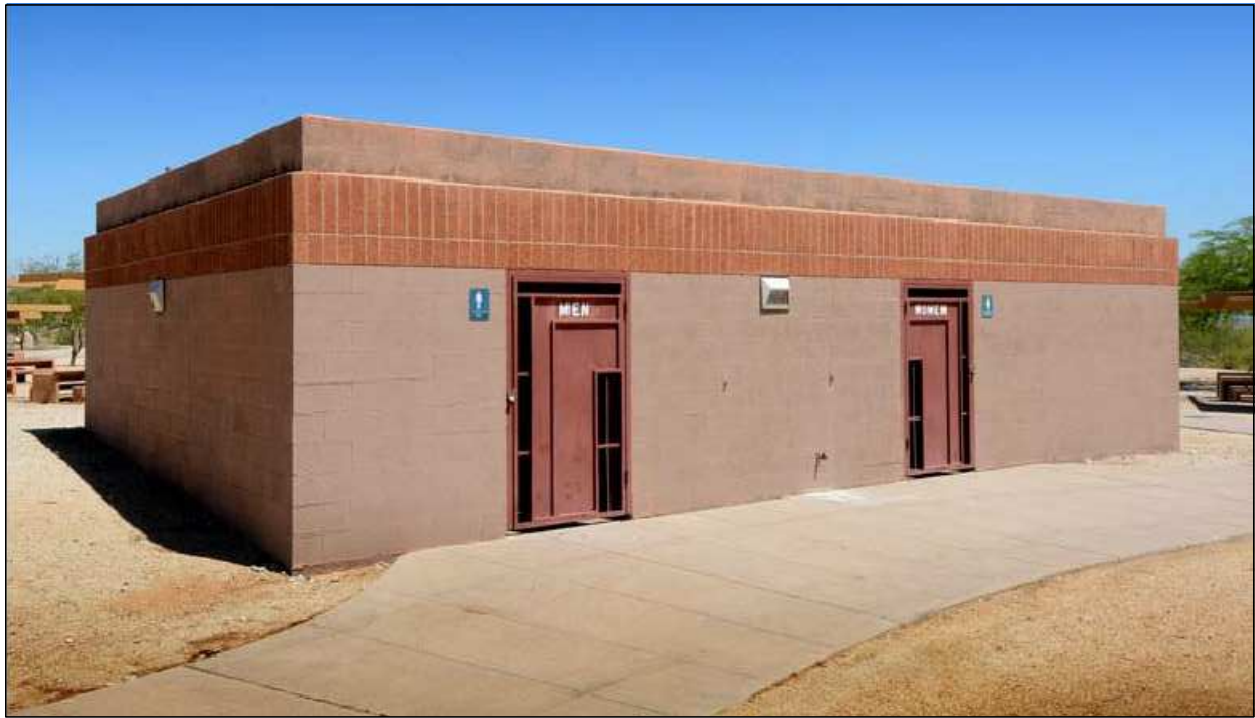
Photograph of Restroom Building

Recommendation: The restroom buildings should be renovated to meet current building and accessibility codes and their appearance should be altered to comply with the City's park style architectural guidelines. The porcelain plumbing fixtures should be replaced with stainless steel, vandal resistant fixtures.

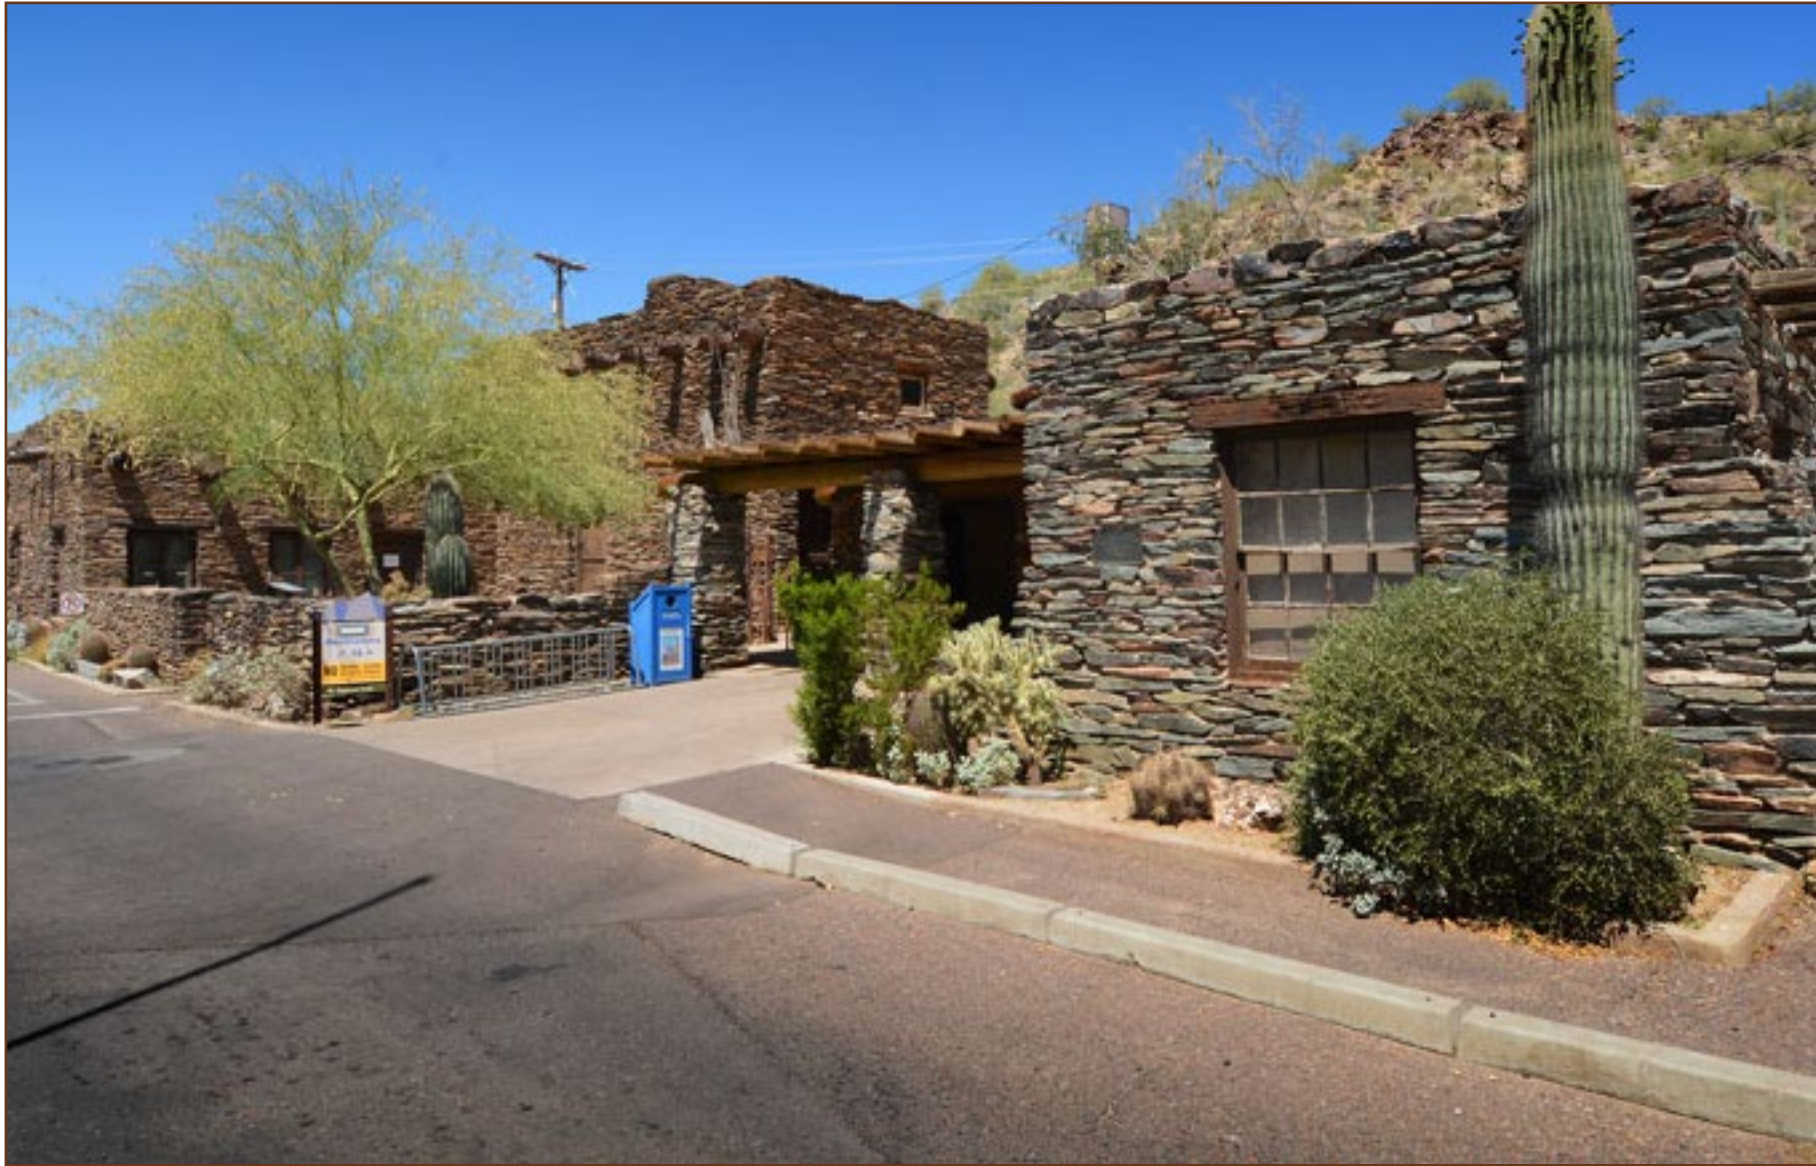
Existing Conditions

Currently, the Concessionaires Quarters and Museum Building function as office space for the South Mountain Park administration and rangers. The Caretakers Quarters has been vacant since 2009. The compartmentalized interior spaces are poorly suited for office use and are not of adequate size for the current and future administrative office needs. Rehabilitating these historically significant buildings for educational or interpretive purposes, or to provide park amenities, is an appropriate use consistent with the Secretary of the Interior guidelines and the South Mountain Park Master Plan.

Recommendations: Currently the Concessionaires Quarters and Museum Building function as office space for the South Mountain Park administration and rangers. The Caretakers Quarters has been vacant since 2009. The compartmentalized interior spaces are poorly suited for office use and are not of adequate size for the current and future administrative office needs. Rehabilitating these historically significant buildings for educational or recreational purposes would be considered appropriate uses consistent with the Secretary of Interior Standards guidelines and the South Mountain Moutain Park Master Plan.

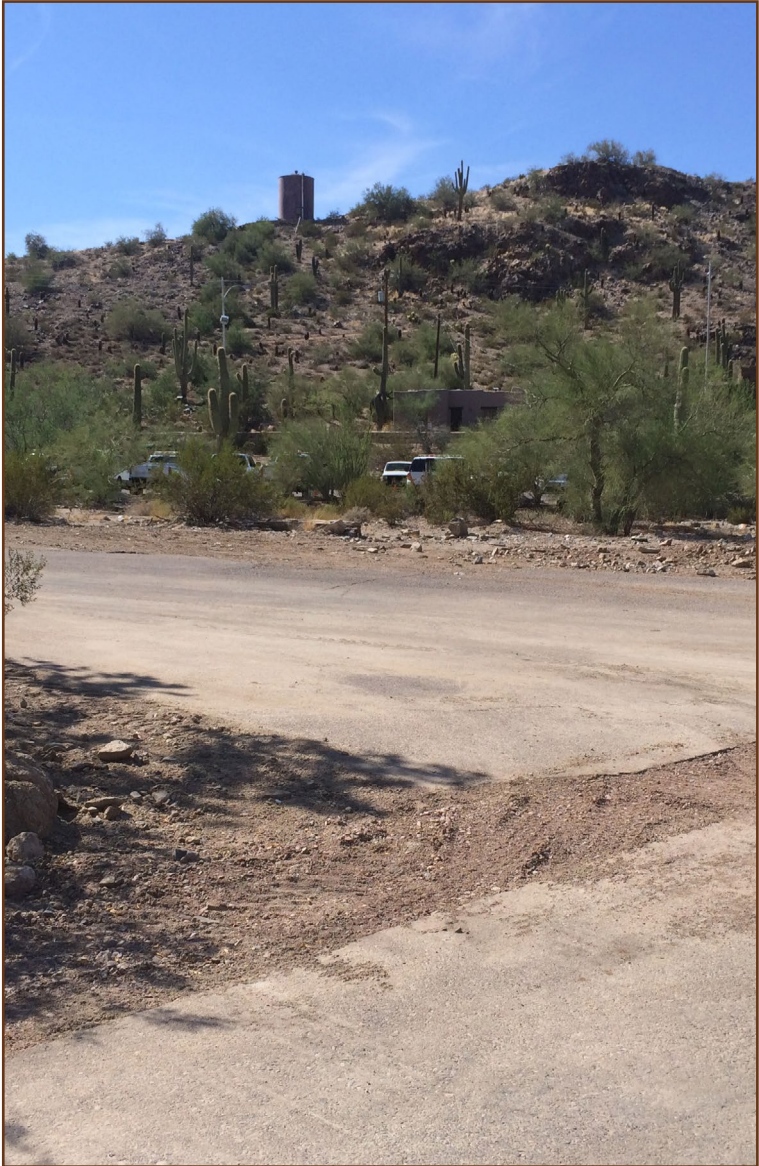
Existing Conditions

The Maintenance Facility is in poor condition and in need of new expanded facilities to accommodate the needs of the South Mountain Park maintenance staff and equipment. The Ranger Station is a proposed new facility situated adjacent to the existing maintenance facility, which will be renovated to consolidate operations of South Mountain Park.

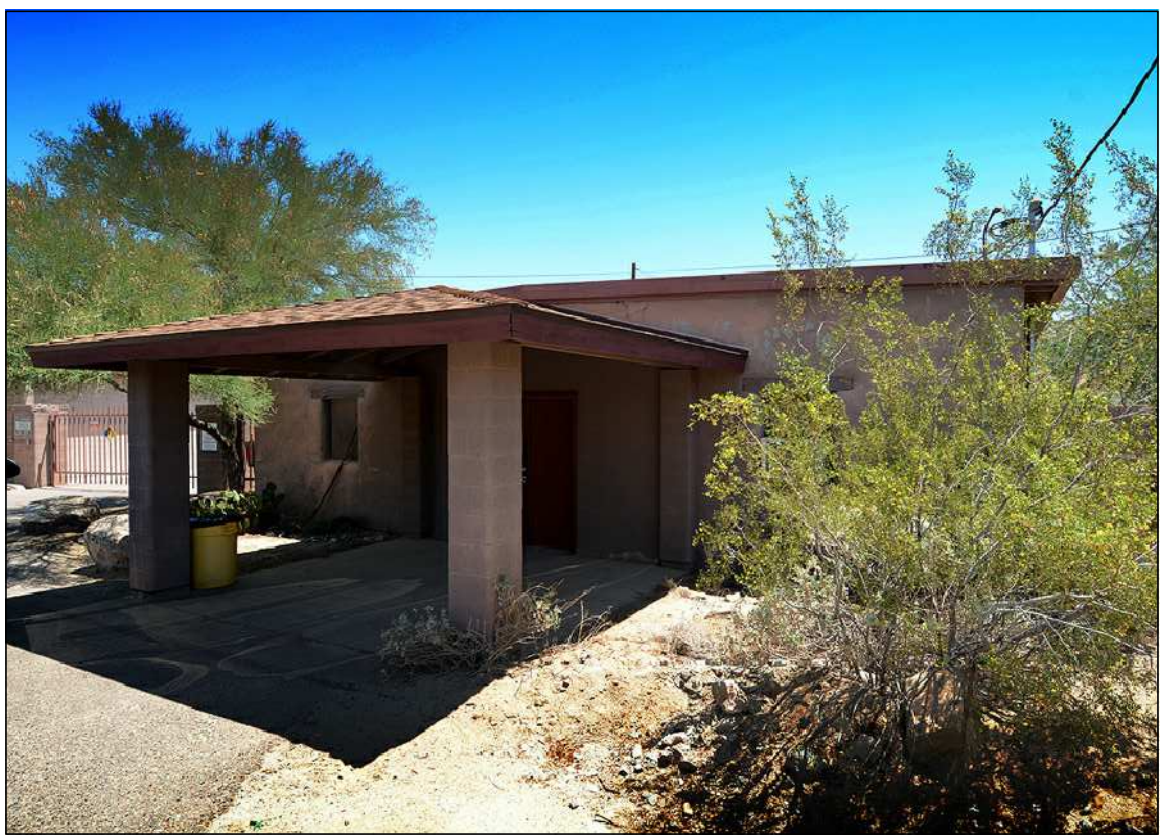
Photograph of Adobe Building

Recommendations: Demolish the adobe building and additions in their entirety and construct an approximately 1200 s.f. addition to the east side of the maintenance building. Replace the poorly crafted, small canopies with larger canopies constructed from steel components.

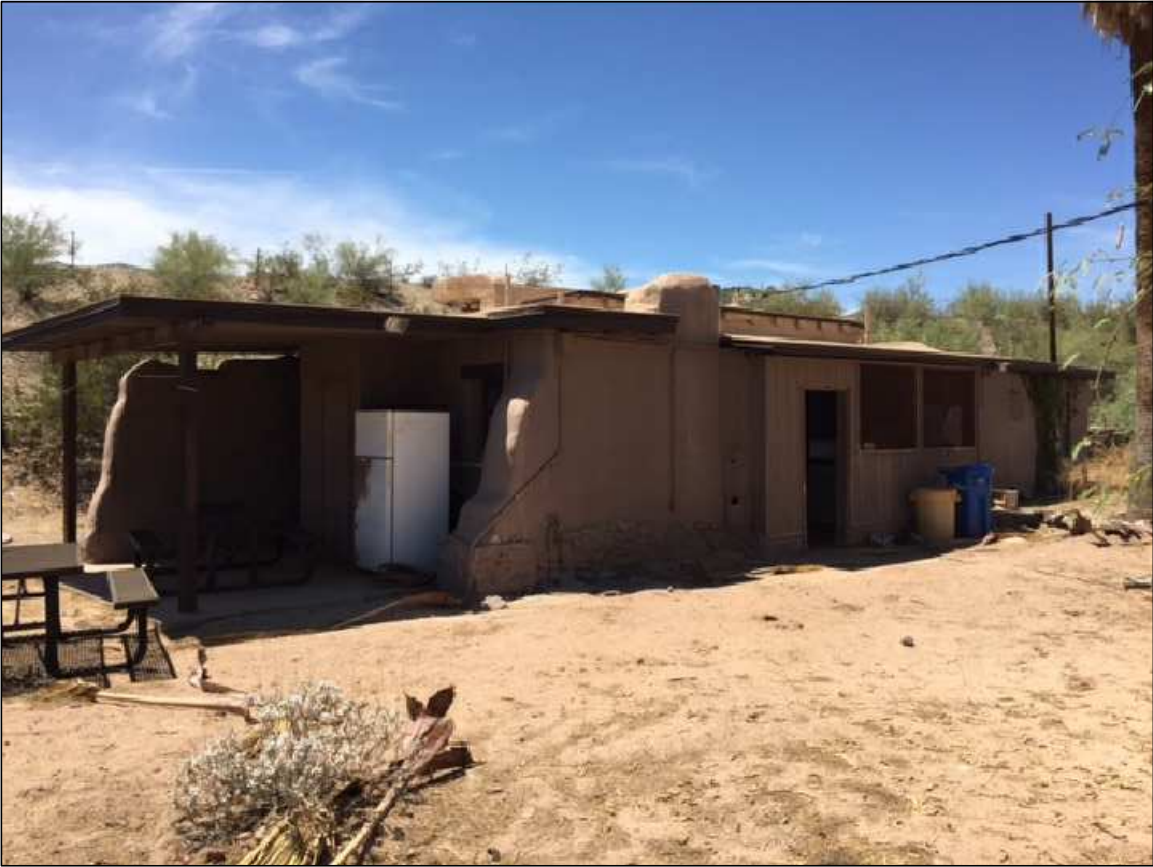
Existing Conditions

Description: The original one-story house was probably constructed in the 1940's and used originally as the living quarters for the park caretaker. The adobe pueblo revival styled house is historically significant for the type of materials and methods used for its construction. Currently, the caretaker's house is used as a dormitory for environmental groups assisting with park rehabilitation projects. The original house includes a living space, kitchen, bedroom, bathroom, porch, and carport. Later additions and alterations included two bedrooms, a closet and enclosing the entrance porch. The original exterior parapet walls consist of stacked adobe bricks covered with stucco on the exterior side and plaster on the interior side. Exposed vigas support the wood roof framing which is covered with a thin polystyrene foam system. Some original wood windows with true divided lights still remain. Later additions were constructed with concrete masonry units and wood framing.

Overall, South Mountain House is in poor condition, Unsympathetic renovations, weathering, and neglect have not been kind to certain interior and exterior elements. However, many of the historically significant elements such as the original adobe brick walls and some wood windows are in fair to good condition and should be restored and/or rehabilitated for continued use.

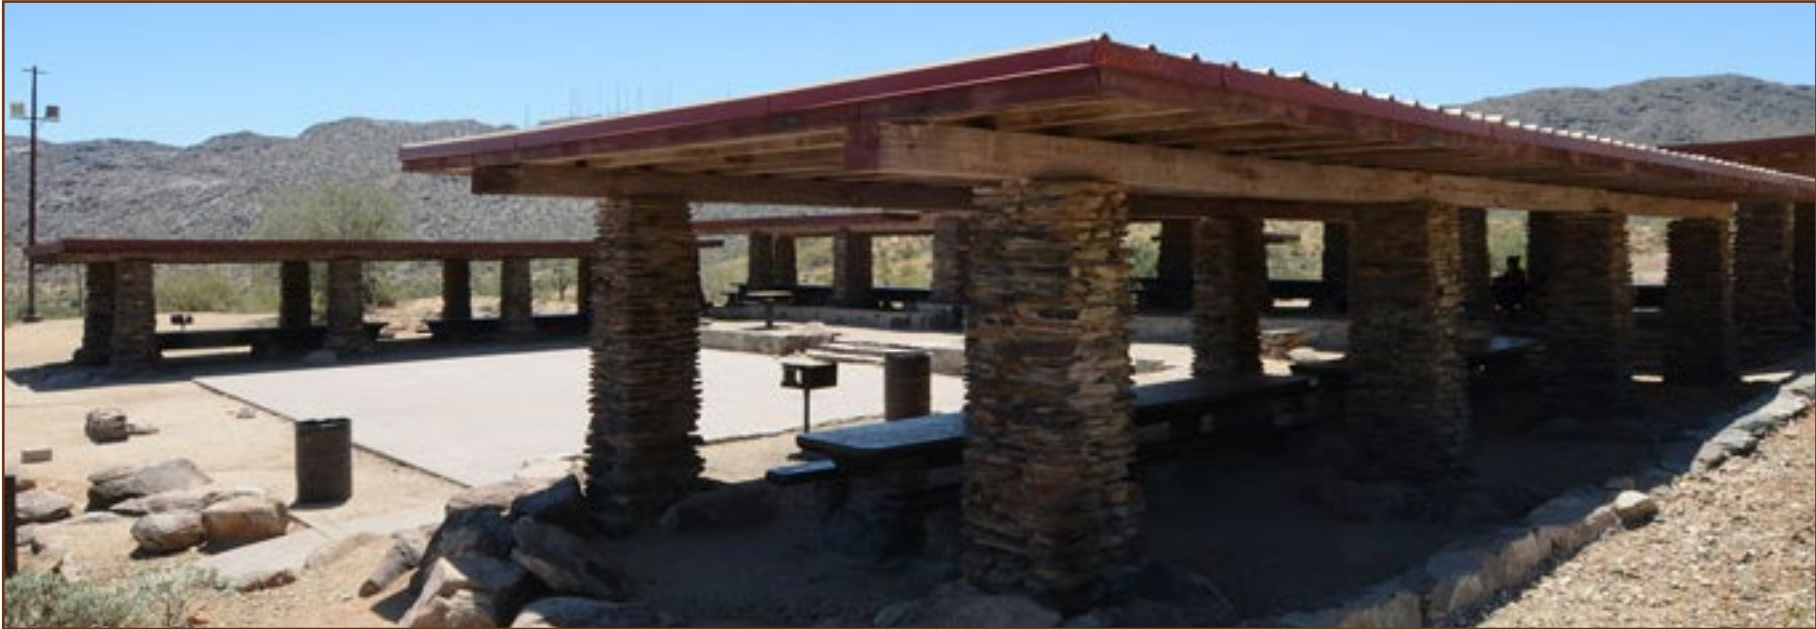
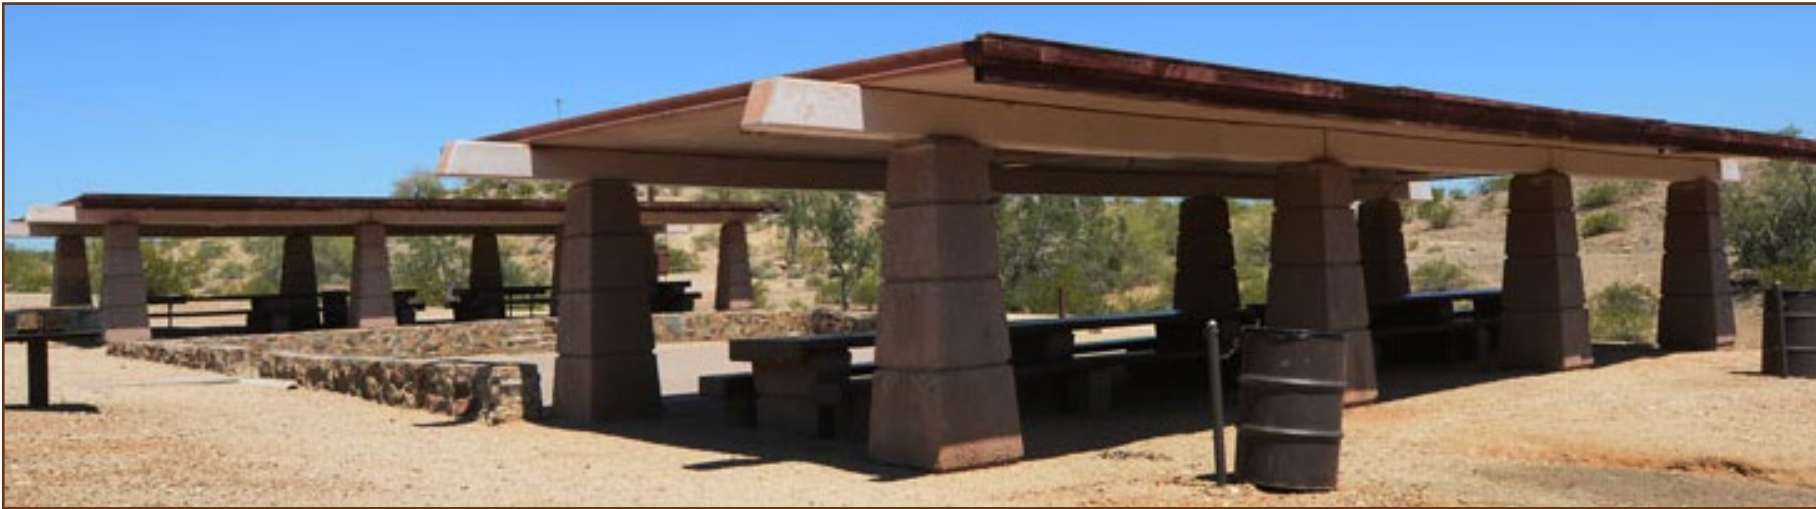
Existing Conditions

The Big Ramada consists of several smaller ramadas grouped around a concrete slab. The Little Ramada consists of two parallel ramadas separated by a large concrete slab. Both are ideally suited for large groups and events.

The Big Ramada is approximately 45 years old and is deteriorating from weathering, neglect, and poor design. Many of the wood beams are warped, split, and lack a protective finish. The rubble stone and mortar piers appear to be in good condition. The wood fascias are warped, weathered, and inadequately attached to the wood beams. The continuous metal drip trim overlaps the roof covering allowing water to seep between the wood roof framing members.

The Little Ramada’s tapered piers have minor surface cracks and the wood fascia is weathered, poorly attached, and is missing in several locations. The concrete beams and precast concrete roof panels appear sound and in good condition. The large patio’s concrete surface is weathered, cracked, and overall in fair condition.

Recommendation: Rehabilitate the ramadas to minimize maintenance, improve their appearance, and revitalize the South Mountain Park image. Recommended rehabilitation measures include restoring the rubble stone piers and replacing the wood roof framing, wood fascia, and flat metal roof panels with sloped steel butterfly roof framing and preformed metal roof panels and trim. Repair / patch cracks in the existing concrete patio slab.

Recommendations: Revitalize the overall appearance of the Little Ramadas and eliminate exposed wood members/trim. Recommended rehabilitation measures include sandblasting the cast-in-place concrete piers to expose the underlying multicolored aggregate and replace the concrete beams, precast roof panels, and wood fascia/trim with sloping steel butterfly roof framing, preformed metal roof panels, and metal trim. Rehabilitate the concrete patio by filling cracks wider than 1/8-inch and replacing concrete deteriorated beyond repair.

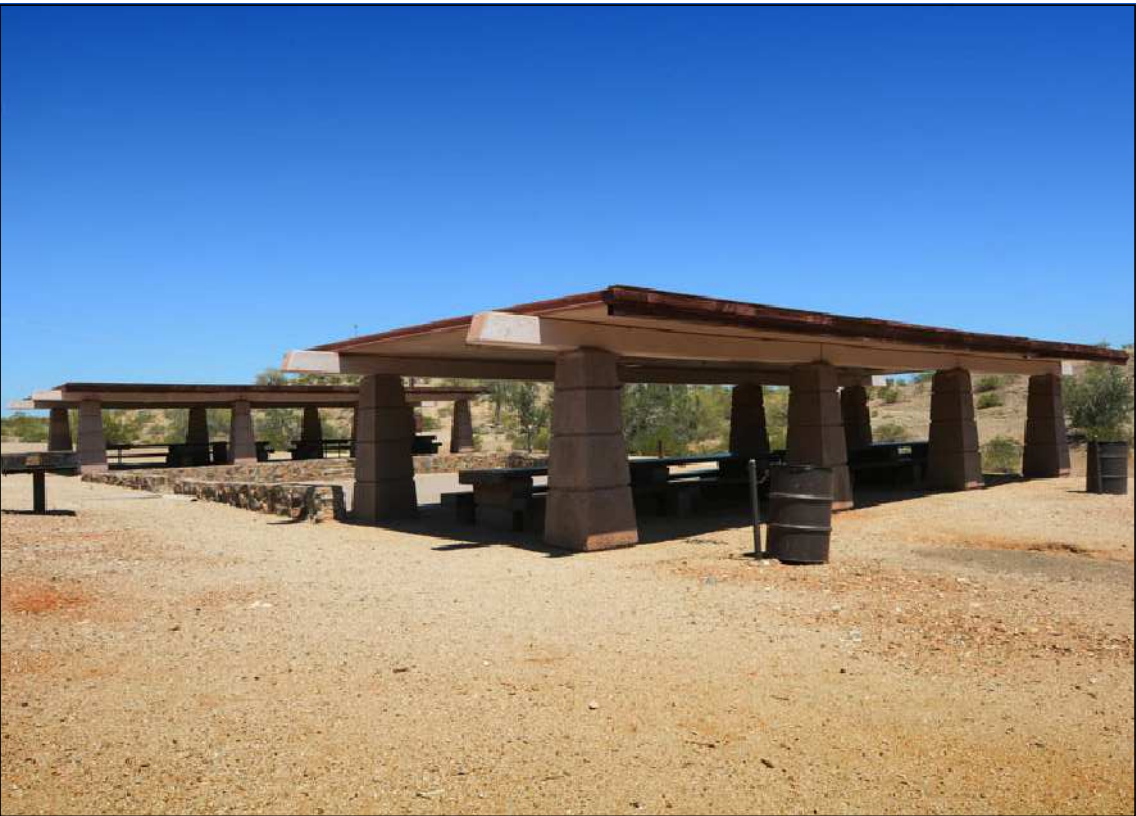
Photograph looking north at Little Ramadas

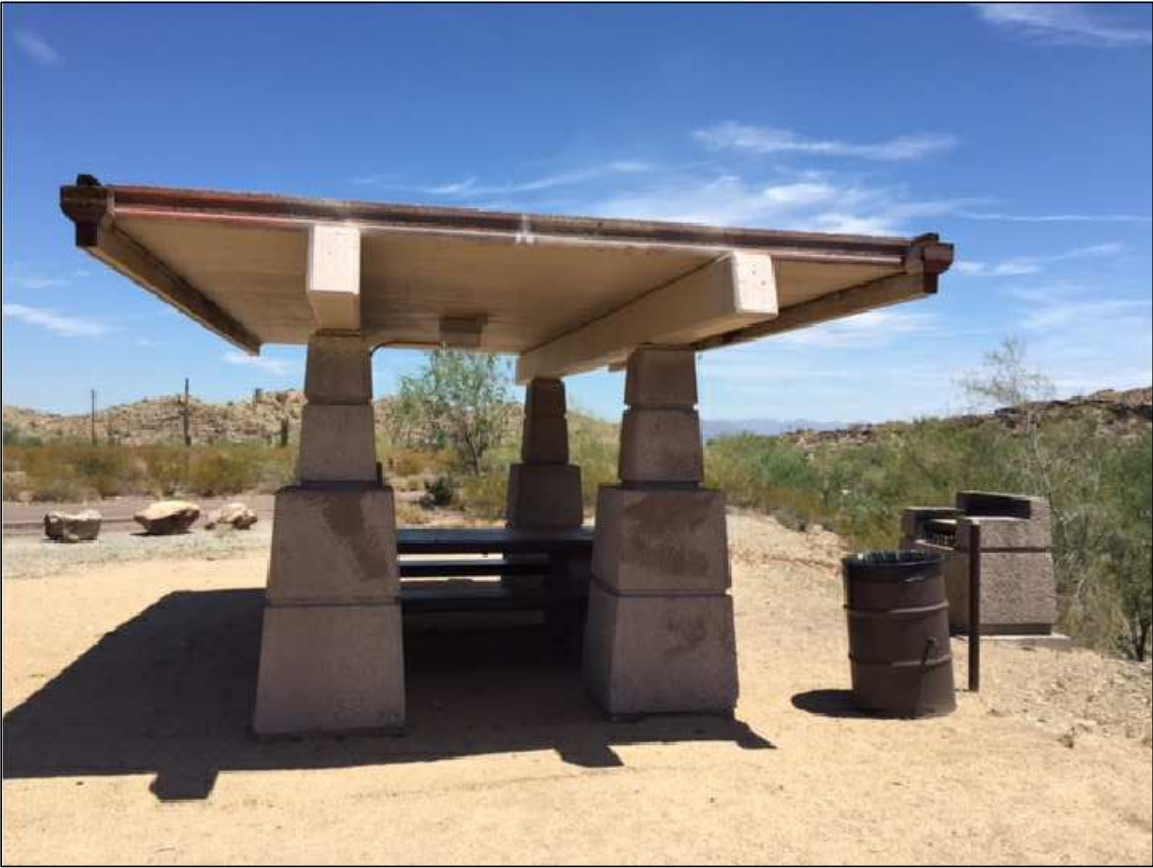
The ramada’s tapered, cast-in-place concrete piers appear to be in fair condition but their mass and spacing allows limited space for seating and circulation. The precast concrete tongue and groove roof panels and beams also appear to be in fair condition. The wood fascia is missing in several locations and is poorly attached to the concrete roof panels. The exposed wood is weathered, lack a protective paint finish, and is in poor condition. The ramada’s concrete piers are disproportionate to its overall size and do not compliment the natural environment.

Photograph at existing ramadas

Recommendations: Replace the 5-Table Ramadas with new 12'X16' steel framed ramadas with cantilevered metal roofs that provide unobstructed views and seating/circulation space.

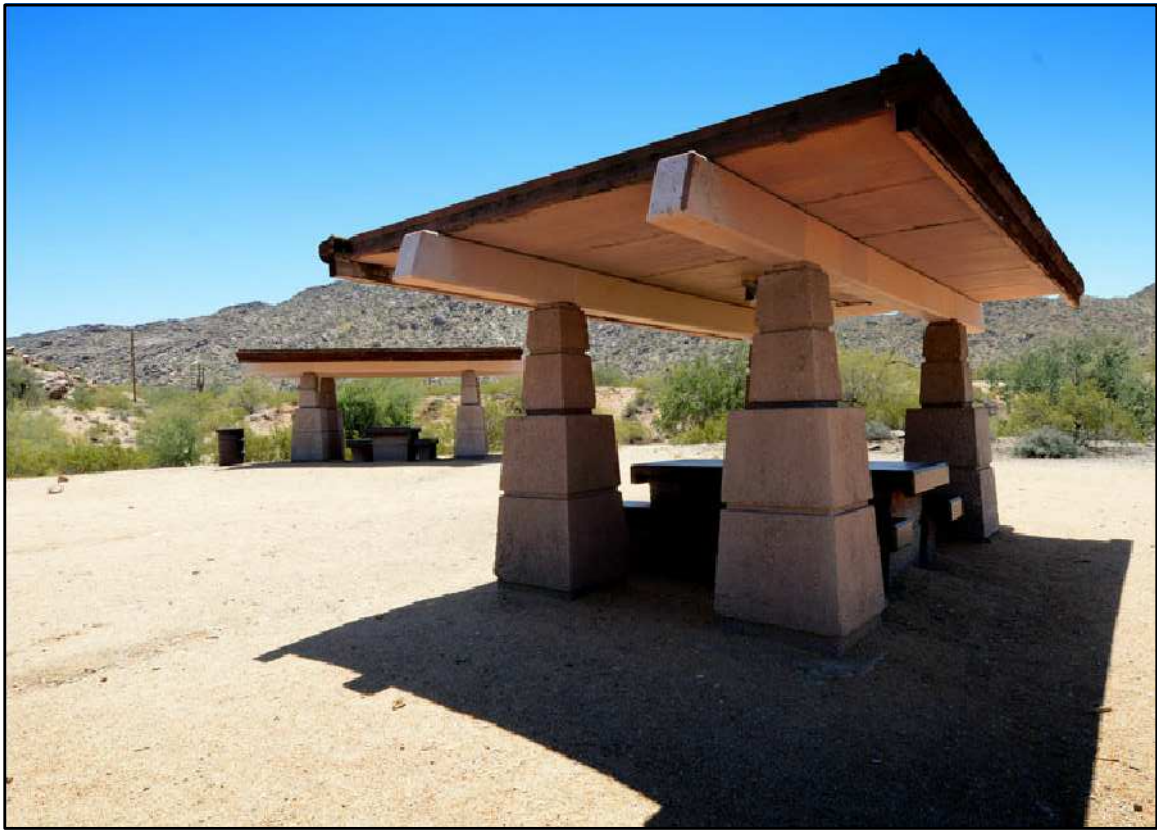
Condition: The tapered, cast-in-place concrete piers appear to be in fair condition but their mass greatly limits the space (below roof) for seating and circulation. Likewise, the precast concrete tongue and groove roof panels and beams appear to be in fair condition. The wood fascia is missing in several locations and is haphazardly attached to the concrete roof panels. The exposed wood members are weathered and in poor condition.

Photot looking at two existing ramadas

Recommendations: Replace the 3-Table Ramadas with new steel framed ramadas with cantilevered metal roofs that provide unobstructed (below roof) seating/circulation space.

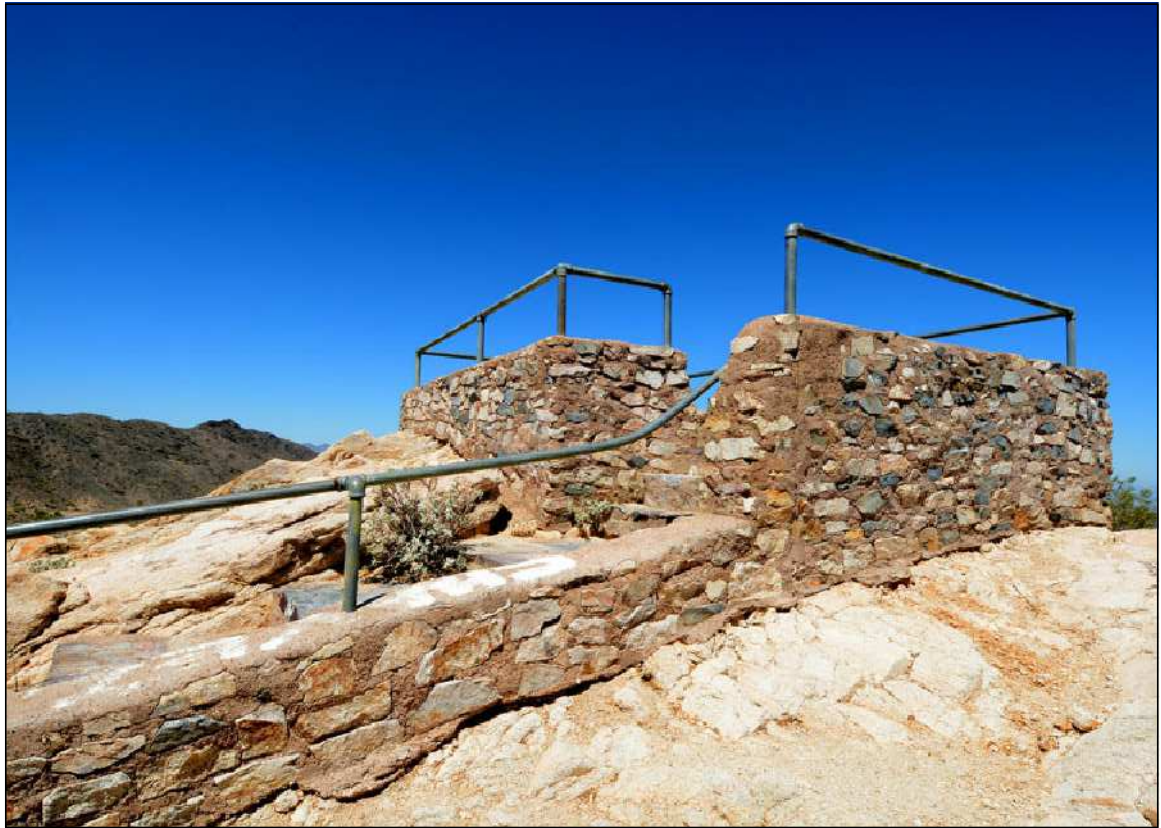
Photo looking northwest at Holbert Lookout

Recommendations: Replace the galvanized steel pipe guardrail and handrail with a more appropriate material compatible with the lookout's overall character and in conformance with the intent of current building codes. Constructing an accessible route to the steeply elevated lookout is probably not feasible.

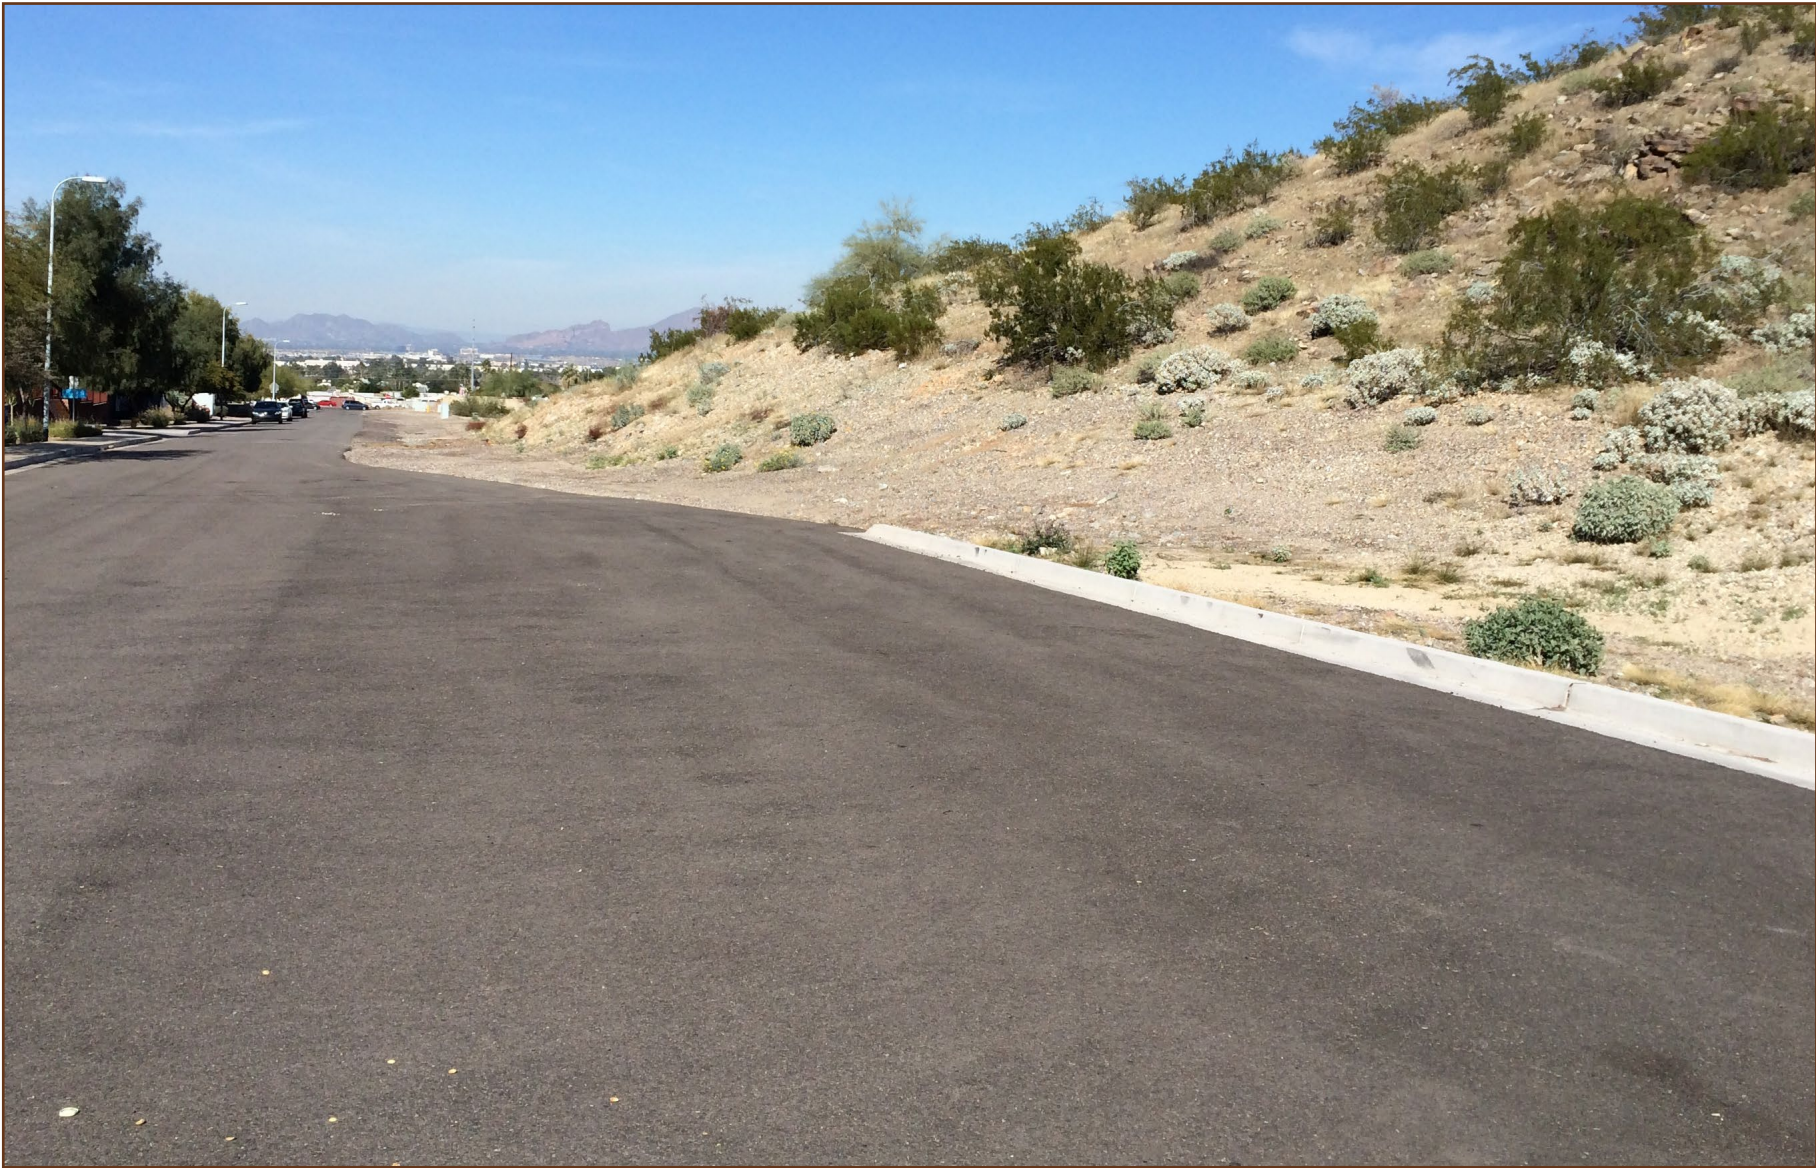
Existing Conditions

Walk in trailhead with no designated trail or parking locations. At current, an easement is needed to cross private property to the Park Preserve. Limited access to this site.

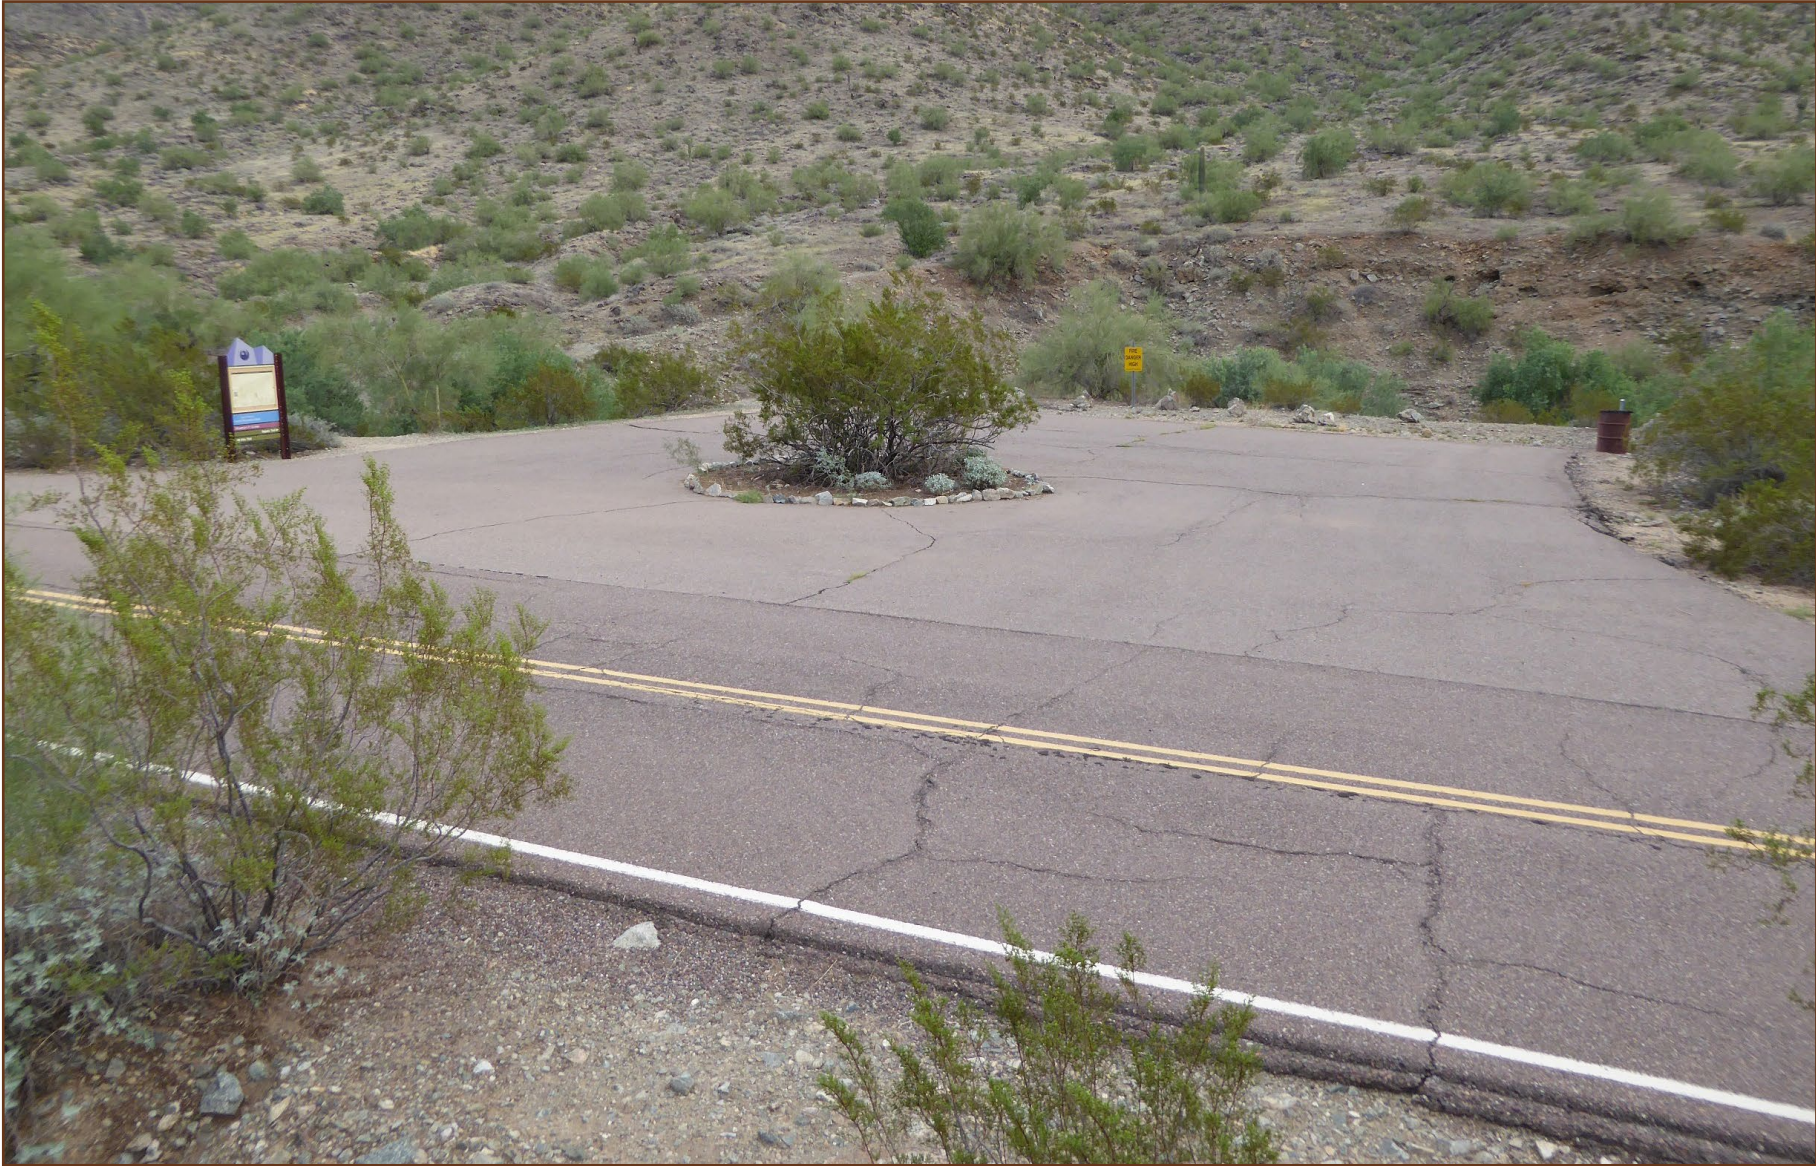
Existing Conditions

The trail entrances are adequately marked and discernible. Most of the facility is deteriorating from normal wear and tear, age, weathering, and lack of maintenance. The current facility is in fair condition and has been underutilized.
