Residential Sound Mitigation Services, Phoenix Historic Property Survey for the City of Phoenix Aviation Department Community Noise Reduction Program

Final Report
May 7, 2007

Submitted by: The Phoenix Historic Preservation Office
Prepared by: Liz Wilson, Historic Preservation Planner
Jodey Elsner, Historian
Scott Solliday, Historian

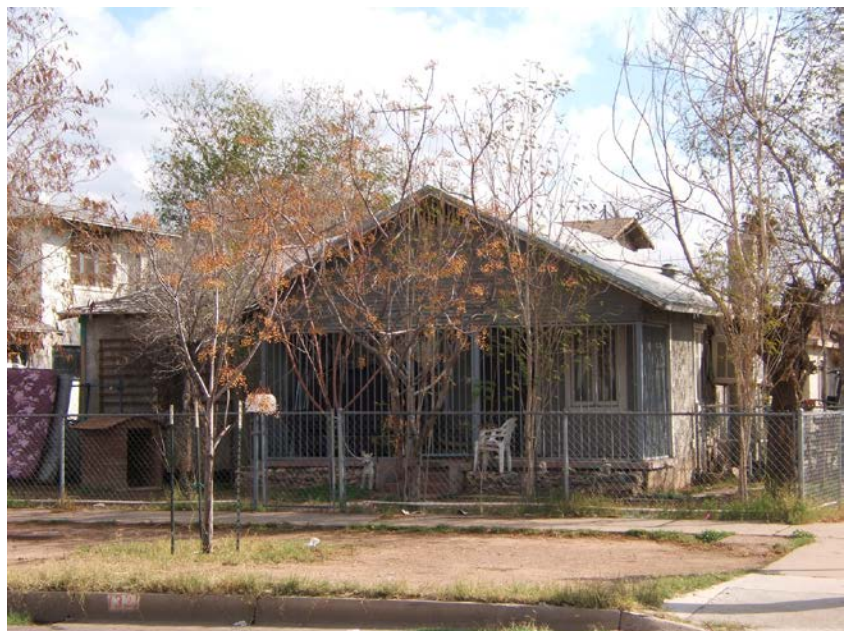
Negative No.: DSCF0023.jpg

Fair (Some problems apparent) Describe: wood gable ends and wood windows are deteriorated

Roof: asphalt shingles Foundation: concrete

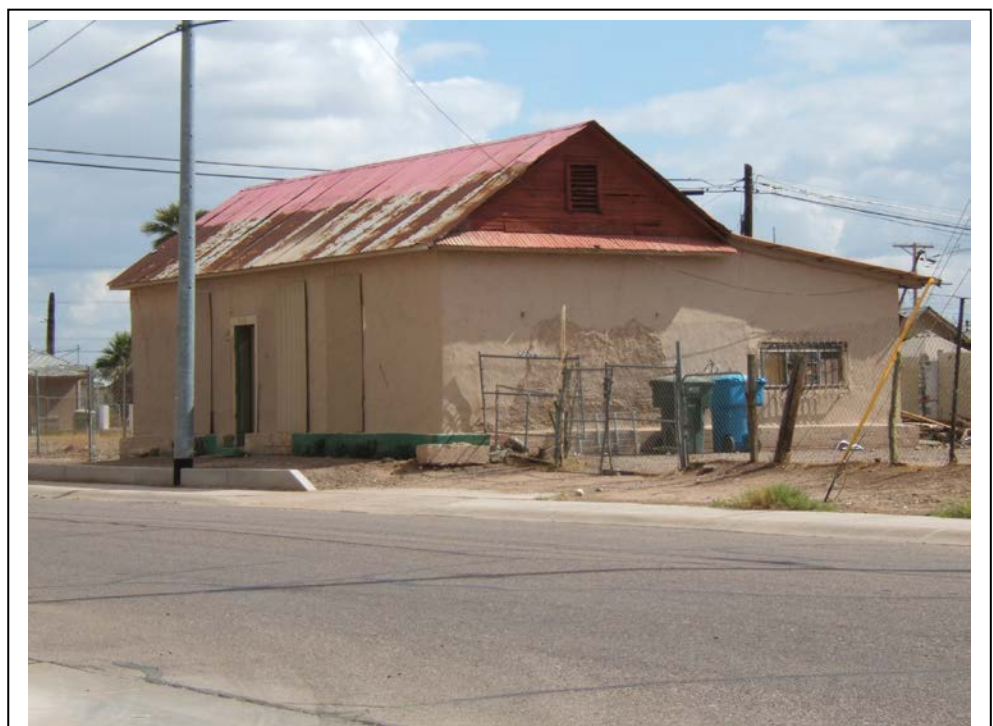
Negative No.: 515 W Hadley SE.jpg

4. MATERIALS (Describe the materials used in the following elements of the property)
Walls (structure): adobe Foundation: concrete Roof: gable and shed
corrugated metal
Windows: unknown (boarded up)
Wall Sheathing: stucco
If the sheathing has been altered, what was it originally? _____

5. WORKMANSHIP (Describe the distinctive elements, if any, of craftsmanship or method of construction)
Vernacular adobe construction not often found in Phoenix from this era.

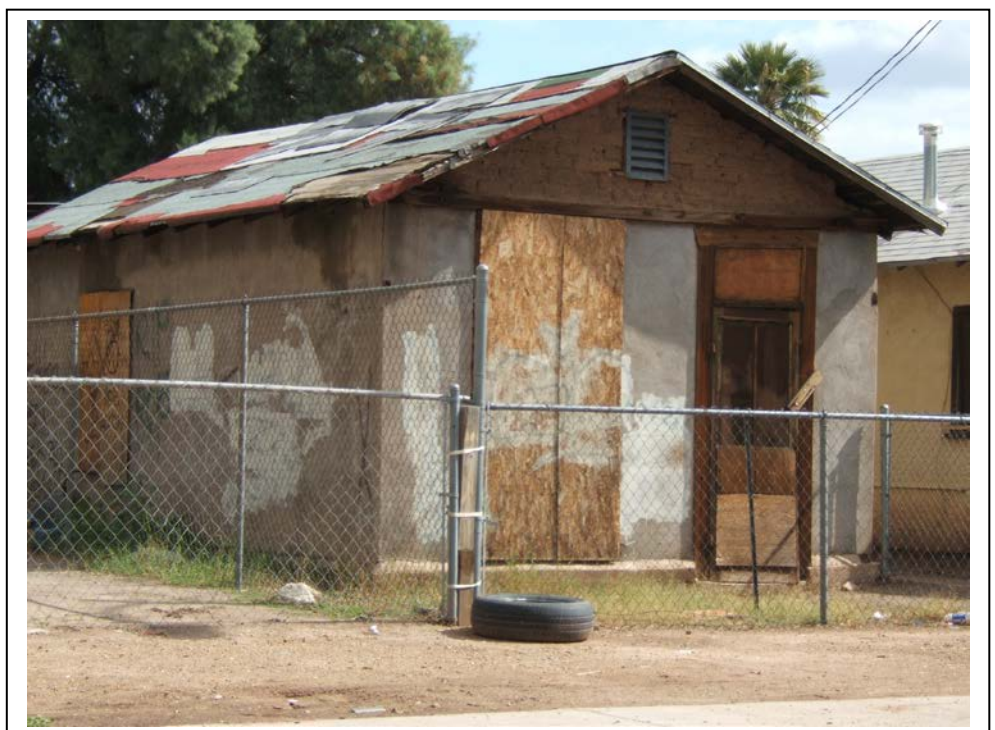
Negative No.: 1015 S 6th Ave SE.jpg

Walls (structure): adobe Foundation: concrete Roof: gable roll roofing
