HISTORIC PROPERTY INVENTORY FORM

For Properties identified through survey: Site No: 1040272 Survey Area: Cuatro Milpas

Address: 1109 S. 13th Place

Name and Affiliation: Ryden Architects

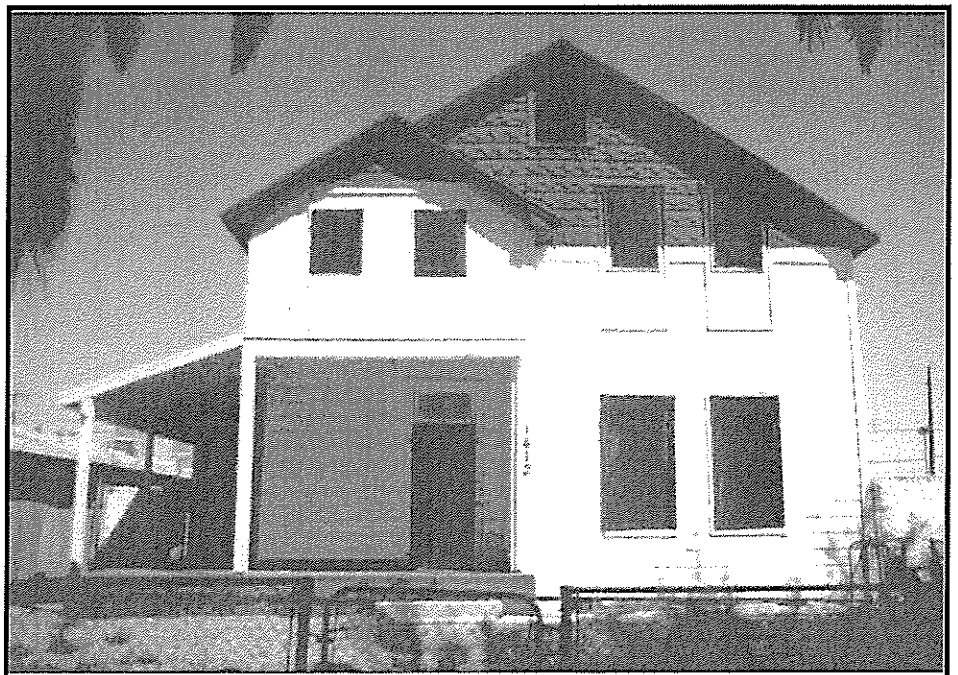
Negative No: A19

Describe: General deterioration of exterior finishes.

Roof: Asphalt shingles Foundation: Unknown
