TECHNICAL MEMORANDUM

20th Street Bicycle and Pedestrian Facilities Improvement

Maricopa Association of Governments Design Assistance

Existing Conditions

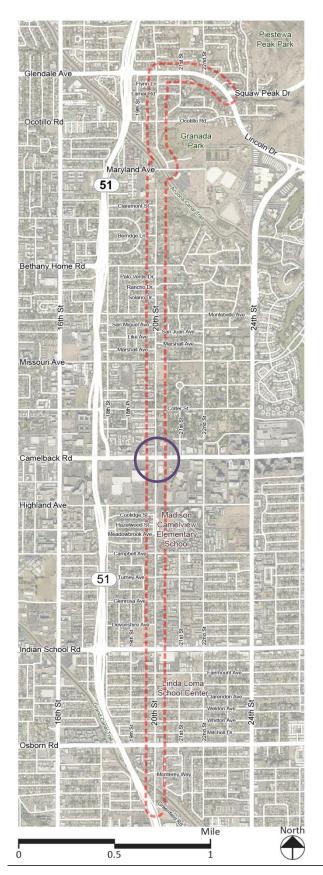
Camelback Road at 20th Street

Pedestrian Counts

Bicycle Counts

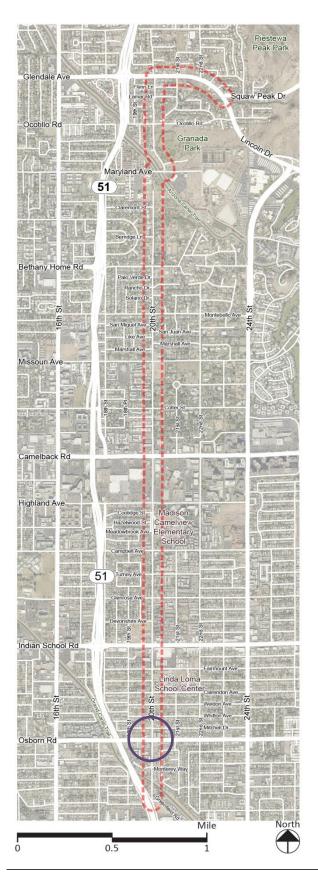
Osborn Road at 20th Street

Pedestrian Counts

Bicycle Counts

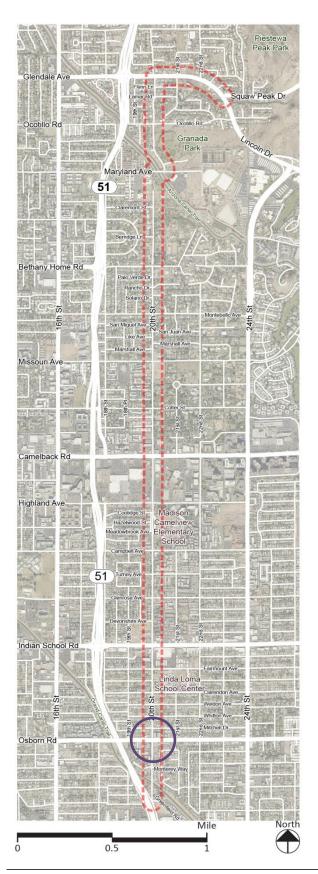
Osborn Road at 20th Street

Pedestrian Counts

Bicycle Counts
