STUDY: EFFECTIVENESS OF EXISTING GREEN INFRASTRUCTURE IN PHOENIX

8426900000-4400000001

City of Phoenix Contract No. 143989

December 28, 2018

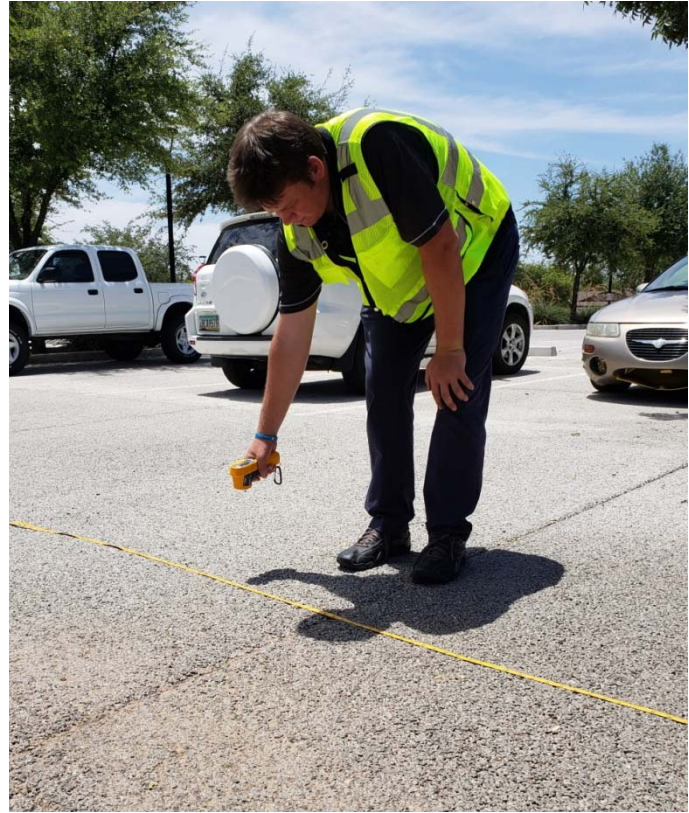
Temperature measurement at Helen Drake Center

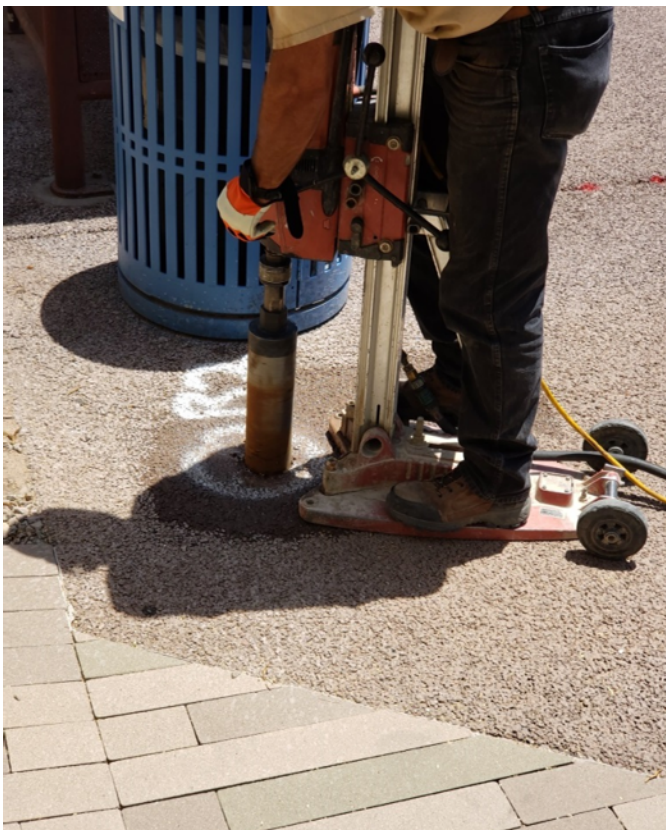
Pavement boring at Central Station

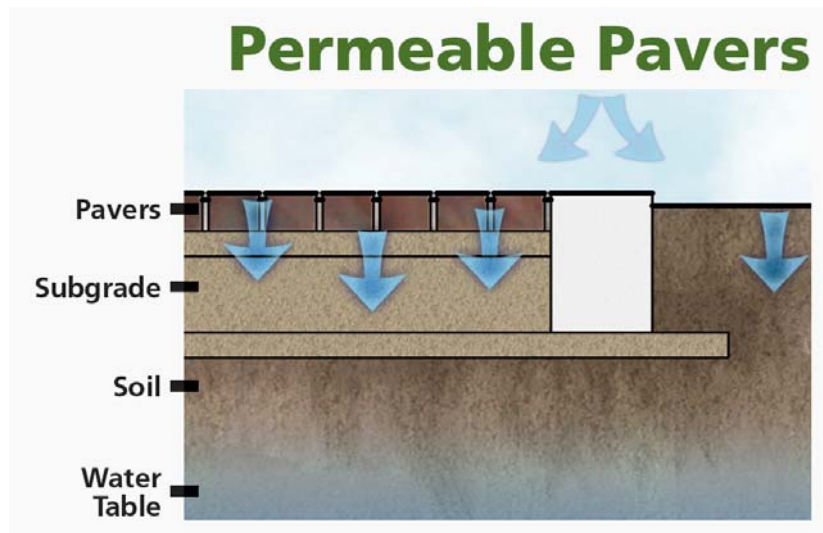
Permeable Pavers Infiltration

reduction of heat island effect, and enhanced community character. While the four City of Phoenix permeable paver sites studied in this report certainly benefit from an enhanced community character, three of the four sites performed poorly on mitigation of runoff and reduction of heat island effect.

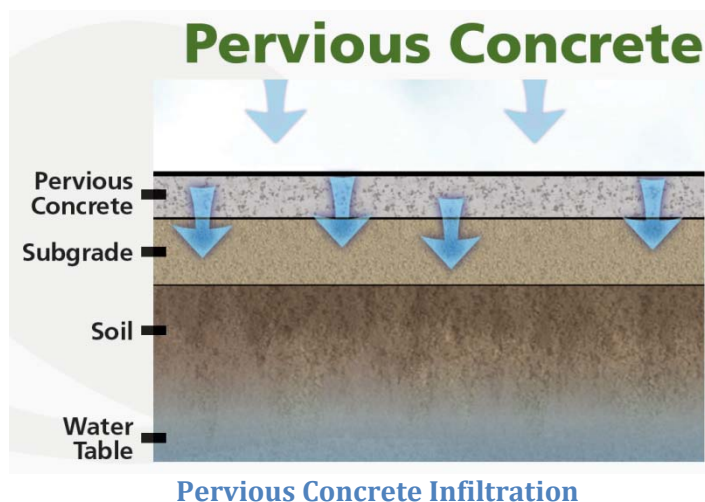
increase land utilization by reducing retention areas. The City of Phoenix pervious concrete sites studied exhibited varying degrees of performance ranging from poor to excellent.

The sites that performed poorly were Civic Space Park, Central Station, Hatcher Road, and Fire Training Academy. Central Station performed poorly either due to sediment or mix design issues (too much cement). Blockage is preventing runoff from infiltrating into the pervious concrete voids. Hatcher Road, Fire Training Academy, and Civic Space Park performed poorly mostly due to sediment and debris filling surface voids. The sites that performed excellent were Tovrea Castle and Helen Drake Senior Center. Both of these sites mostly exhibited high infiltration rates and were well maintained with the exception of a few pockets of sediment and debris occurring mostly at sump locations.
